RESTORATION OF A BRIDGE STRUCTURE ON THE EXAMPLE OF A BRICK RAILWAY VIADUCT IN ZIELONA GÓRA

Abstract

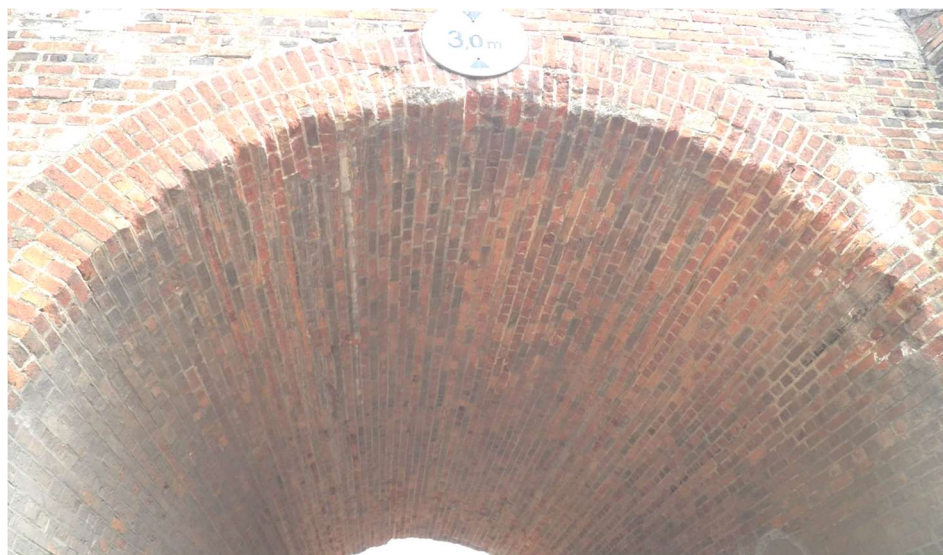
The described damage is well illustrated by the photograph found in Figure 2.

The expert opinion covered the verification of the dimensions of the structure as well as the analysis of the foundation of the structure based on local uncovers of the foundation. It was determined that the current state of scratches is of a superficial nature, lowering the esthetic value of the structure, and does not comprise damage which may affect the safety of the operation of the viaduct structure..

Fig. 2. View of the outline of the brick vault of the railway viaduct

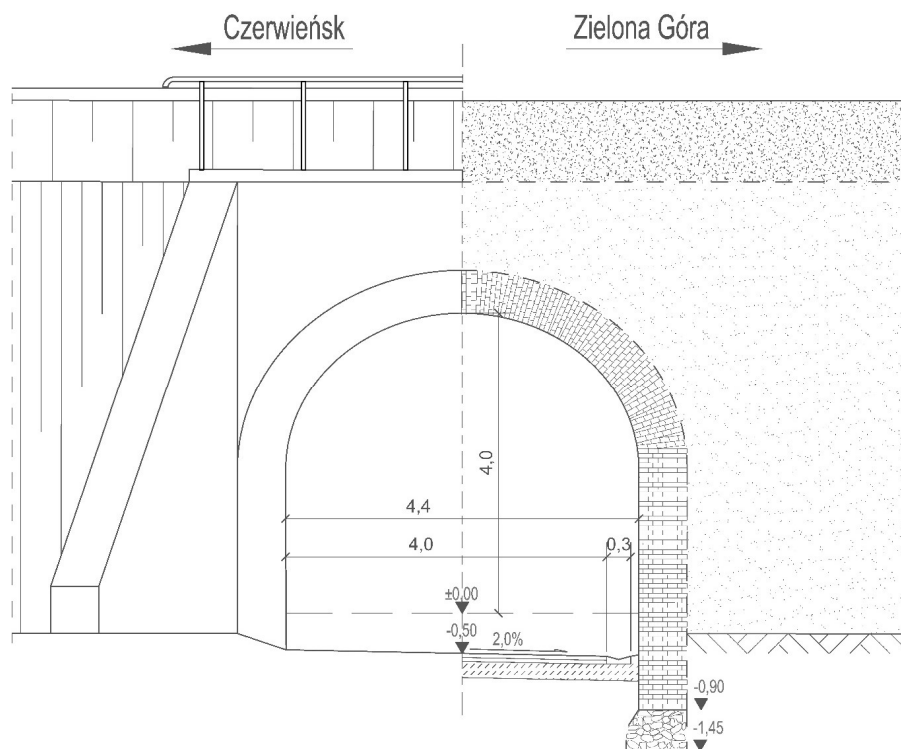
Figure 3 shows the longitudinal view and section of the viaduct, accounting for the designed changes.

Fig. 3. Planned lowering of the roadway under the viaduct

The working plan included lowering of the gradeline of the roadway under the viaduct by 0.50 m, which forced the necessity of changing the access roads to the structure on a length of 40 m.

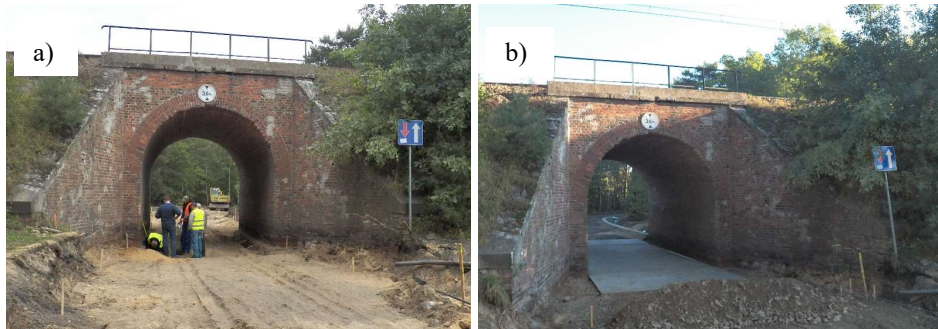
Fig. 4. View of carrying out works on the bridge structure: a) preparing the road bed, b) preparing the expansion slab under the viaduct

The technical documentation called for removing the existing bituminous surface and preparing a new full construction of the roadway.

Additionally, in an effort to ensure an adequate expansion of the arch structure of the viaduct, a reinforced concrete slab, 0.25 m in thickness was designed under the structure of the road surface.

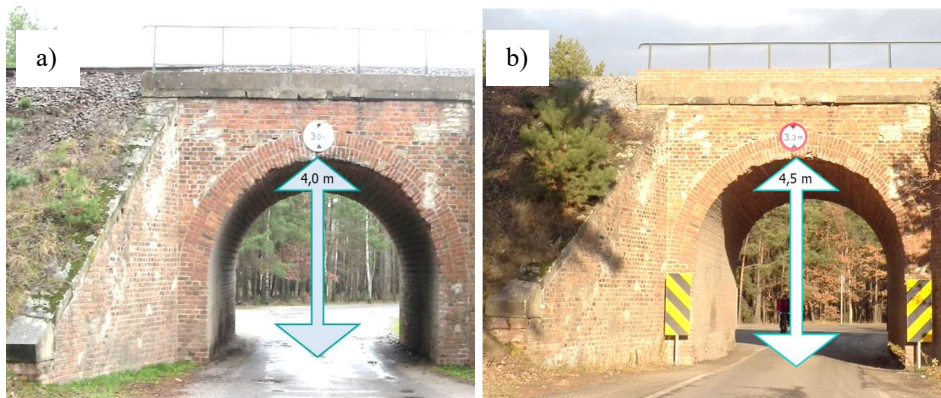
Fig. 5. View of railway viaduct in the course of Folszowa road in Zielona Góra: a) prior to reconstruction b) following reconstruction

Lowering the roadway of Folszowa Street Under the railway viaduct made it possible to increase the vertical clearance from 3.00 m to 3.30 m. Thanks to this, the level of safety, along with the durability of the structure were increased. The presented realization serves to show that the proper preparation of an investment makes it possible to limit financial outlays for eliminating transportation barriers. As had already been mentioned in the introduction, existing engineering structures require reconstruction, mainly in light of continuously increasing transportation needs. Frequently, these structures are of a historic nature or are entered into the Register of Historic Monuments, which significantly limits the possibility of creating modern structures in their place. It is worth, for historic purposes as well as esthetic values, taking an interest to ensure a variety of bridge structures while maintaining their functional values, especially when this is economically validated.
