## RENOVATION OF LARGE-PANEL BUILDINGS IN CONTEXT OF URBAN RENEWAL

### Abstract

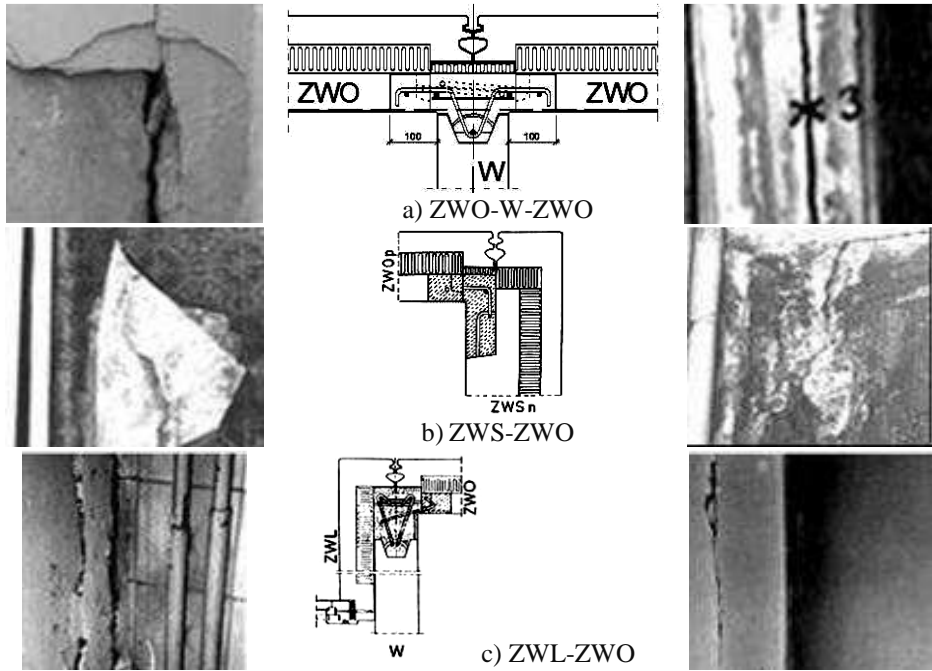
Fig. 5. Examples of cracking due to construction defects in the vertical joint

Cracks in the vertical joints (Fig. 5), as shown in the work [16], do very little to reduce the planned carrying capacity of the load-bearing structure, as curtain walls were not accounted for in structural design calculations. Therefore, if cracks in the joints are of a stable nature and the load bearing construction of the building is intact, adapting the building to construction safety requirements comes down to standard renovation, returning the rooms to their full service potential. This most often involves filling the cracks with mortar or resin and covering them with plaster on a synthetic fiber mesh [8].

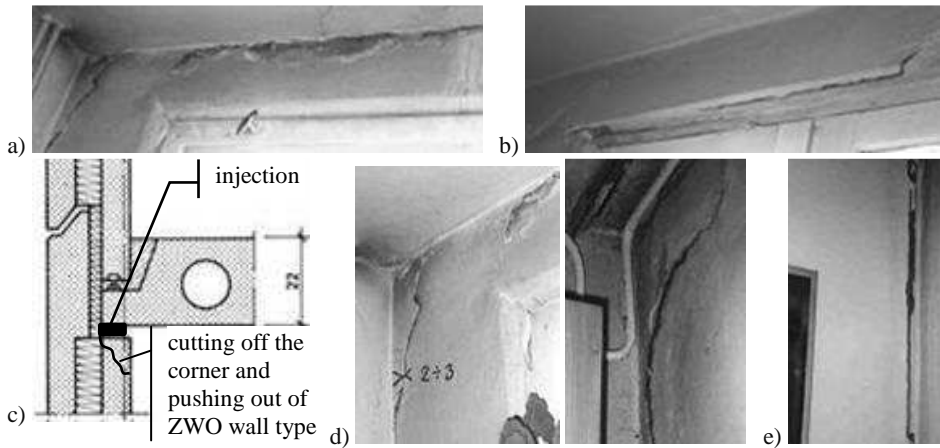
Fig. 6. Examples of damage in horizontal ZWO-S-ZWO wall type joints due to an in-service defect (injection of the gap beneath the floor): a), b), c) cutting off the upper corner of the load-bearing layer of wall and pushing out of ZWO type wall, d) inclination of wall and associated cracking in joints, e) gap with thickness of 5-8 mm between the ZWO type wall and partition wall

When cracks in vertical joints are structural or reveal a tendency to progress (active cracks), or when inclination of the curtain wall has taken place as a result of injecting the expansion gap underneath the ceiling (Fig. 6), it is necessary to remove the source of the cracking and then apply reinforcement in order for the building to meet safety requirements [10, 18]. Reinforcements should be made from the outside (from scaffolding) and should not infringe on

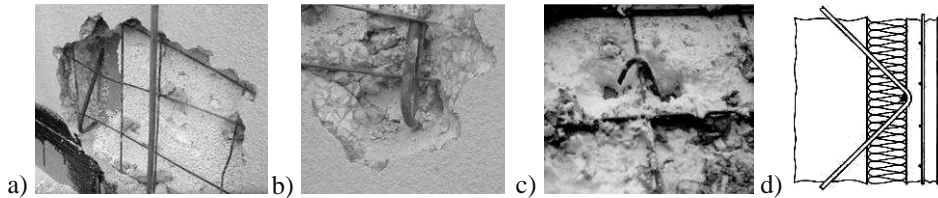
Fig. 7. Examples of faulty assembly of triangular hangers: a) photo by [26], b) photo by [In-westbud], c) photo by [J. Dębowski], d) lack of hanger within the texture layer

Defects in connecting (hooks, pins) the vapor-control layer with the load-bearing layer of prefabricated ZWS and ZWO wall panels (Fig. 7, Fig. 8) and cracks in the vapor-control layer (Fig. 9) are not connected with damage (cracking) in the joints and do not pose a safety threat to the load-bearing construction of the building. However, they do pose a potential safety threat to its use as a result of the possibility of destruction occurring in the vapor-control layer and, in extreme cases, its separation (Fig. 12). The safety threat to the

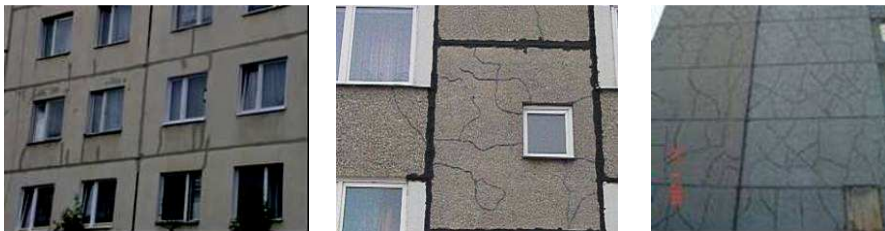
Fig. 9. Examples of characteristic crack patterns in texture layer

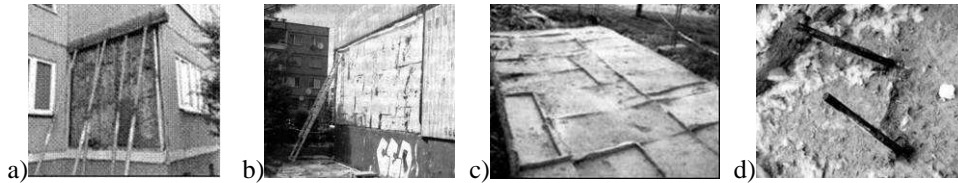
Fig. 12. Effects of the "hidden" construction defects in the joining of the layers: a), b) view of ZWS type walls after separation of texture layer [21, 26], c) view of inside surface of separated texture layer following the removal of mineral wool insulation [21], d) broken bars of hanger anchored within the texture layer [21]
