NON-DESTRUCTIVE TESTING OF WOODEN ELEMENTS IN HISTORIC BUILDINGS - AN EXAMPLE OF TESTING A 19TH CENTURY ROOF TRUSS STRUCTURE

Joanna DROBIEC, Beata NOWOGOŃSKA¹

University of Zielona Góra, Institute of Civil Engineering, Zielona Góra, Poland

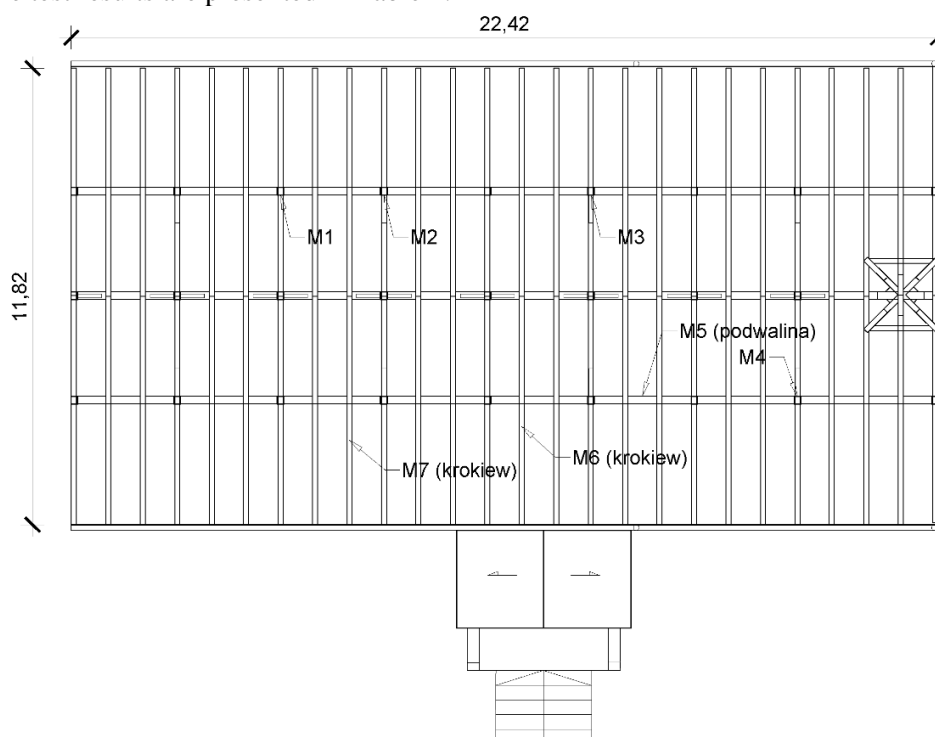
Fig. 8. Test sites of the roof truss components using the hammer for wood

Test site	Biological corrosion	Depth of needle penetration, mm
M1 (column)	No	20.47
M2 (rafter)	No	23.6
M3 (left footing beam)	No	23.63
M4 (horizontal member, left side)	No	23.44
M5 (column)	Yes	33
M6 (rafter)	Minor	29.06
M7 (column)	No	24.2

The qualitative assessment of wood was performed on the basis of the results from sclerometric tests. The needle penetration was deeper in case of corroded elements. An average depth of the needle penetration into the undamaged elements was 23.07 mm at the standard deviation of 1.48 mm (the coefficient of variation was 6.4%), whereas an average depth of the needle penetration into the damaged elements was 31.03 mm.

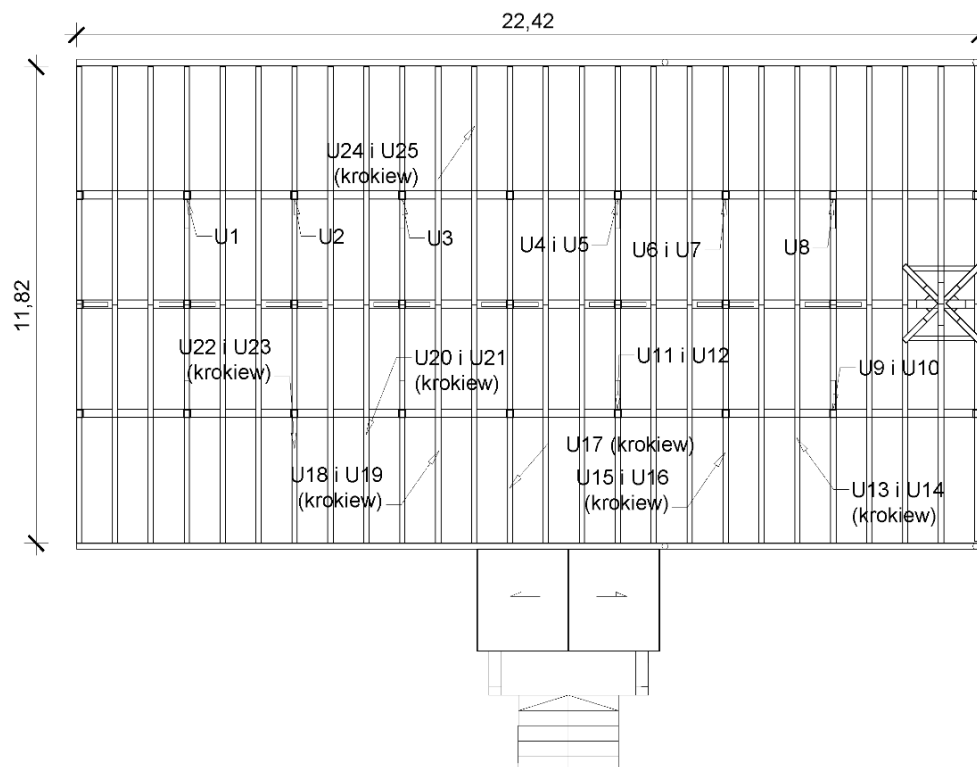
Fig. 9. Test sites of the roof truss components using the instrument UK1401 Surfer

Test site	Biological corrosion	Wood defect	Ultrasonic velocity m/s
U1 (column)	No	No	5510
U2 (rafter)	No	No	5360
U3 (left footing beam)	No	No	5180
U4 (horizontal member, left side)	Yes	No	4930
U5 (column)	Yes	No	4590
U6 (rafter)	No	No	5730
U7 (column)	Minor	Yes	3530
U8 (rafter)	Yes	No	4880
U9 (left footing beam)	No	No	5200
U10 (horizontal member, right side)	No	Yes	3980
U11 (column)	No	No	5270
U12 (rafter)	No	Yes	4900
U13	No	No	5080
U14	Yes	Yes	2680
U15	No	No	5230
U16	No	Yes	4120
U17	No	No	5440

U18	No	No	5130
U19	No	Yes	4010
U20	Yes	No	4270
U21	No	Yes	4150
U22	No	No	5250
U23	No	Yes	4380
U24	Yes	No	4980
U25	No	Yes	3910

The qualitative analysis of the wood was conducted on the basis of the performed ultrasonic tests. An average ultrasonic velocity for the undamaged elements tested with the instrument UK1401 Surfer (a transverse ultrasonic wave) was 5330 m/s at the standard deviation equal to 184 m/s (the coefficient of variation 3.5%). An average ultrasonic velocity for the components with biological corrosion was 4266 m/s at the standard deviation equal to 865 m/s (the coefficient of variation 20%). The instrument UK1401 Surfer was also used to test defects (knots). Nine defect sites were tested with the transducer

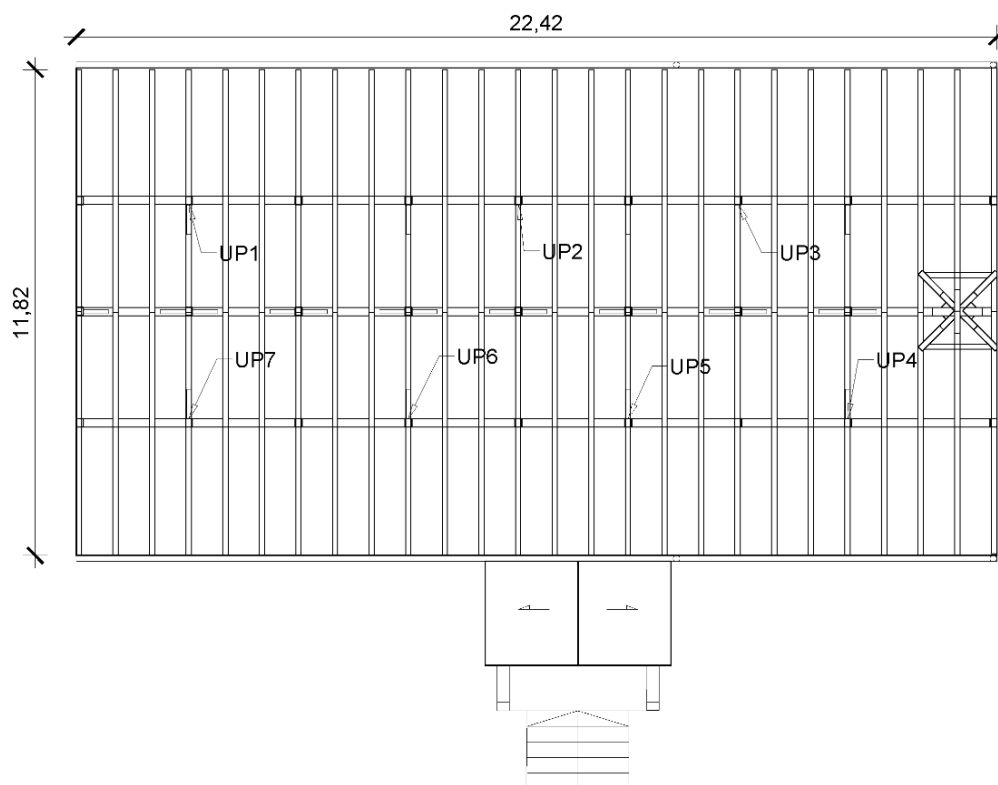
Fig. 10. Test sites of the roof truss components using the instrument UK1410 Pulsar

Test site	Biological corrosion	Timber defect	Ultrasound velocity, m/s
UP1	No	-	2000
UP2	No	-	1780
UP3	Minor	-	1150
UP4	No	-	2200
UP5	No	-	2030
UP6	No	-	1960
UP7	Minor	-	1590

An average ultrasonic velocity for the undamaged components tested with the instrument UK1410 Pulsar (the longitudinal ultrasonic wave) was 1994 m/s at the standard deviation equal to 150.1 m/s (the coefficient of variation 7.5%). This velocity for the damaged elements was lower by 32% and equal to 1370 m/s.

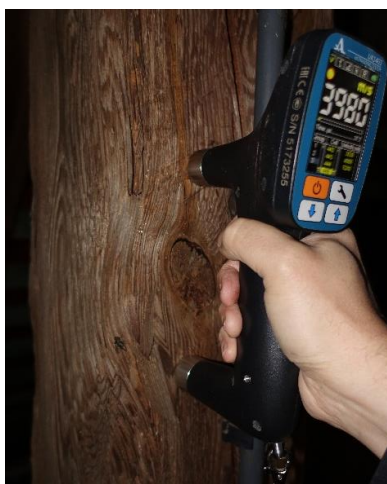
Fig. 11. Method of testing the area near timber defect (knot)

head placed on both sides of the knot (Fig. 11). The determined average ultrasonic velocity was 3962 m/s at the standard deviation equal to 607 m/s (the coefficient of variation 15%). It was clear that ultrasonic velocity near the defect decreased by 25% as the path of the ultrasonic wave flow elongated (the wave passed by the defect).
