ASSESSMENT OF THE TECHNICAL CONDITION OF THE KOSSAK MANOR GRANARY BUILDING IN GÓRKI WIELKIE

Janusz JURASZEK¹, Roman SIRY, Hubert WALUSIAK

Univeristy of Bielsko-Biała, Faculty of Materials Engineering, Construction and Environment,
Department of Construction, Poland

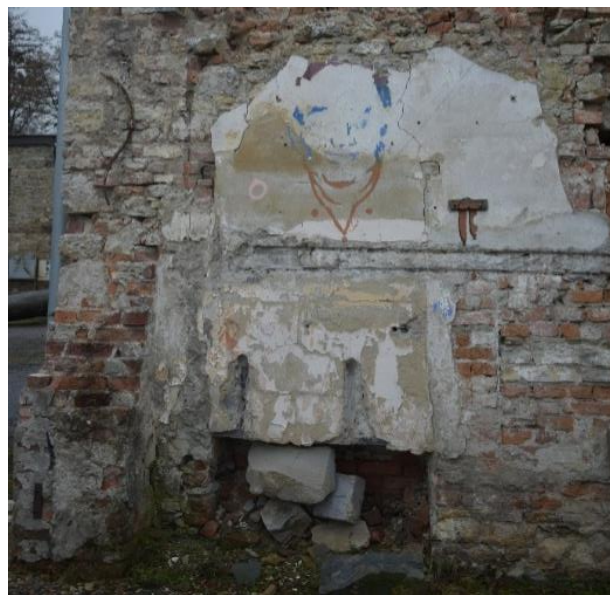
During the technical assessment, it was noticed that the roof, wooden stairs, and ceilings are decayed (biological corrosion), porous, and posed a structural failure risk. Some elements, such as brick walls, are partially damp and frozen, window and door joinery is damaged, and there are gaps and cracks in the plaster on the elevation (Photo 3).

Photo 3. Damage to the western corner of the Kossak Manor Granary

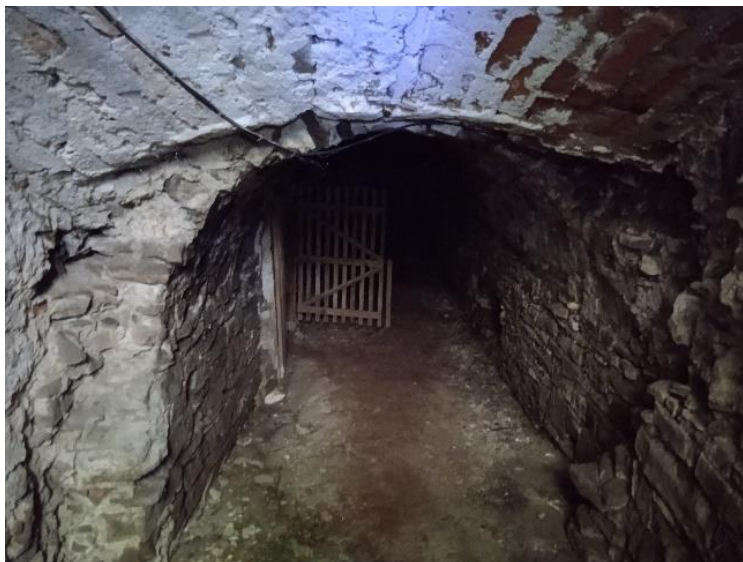
Segment A: The oldest part of the building, made of stone (Photo 4), both walls and vaults. The walls at the foundation level do not have setbacks. Probably, as part of further expansion, rooms were built on the ground floor above the existing basement, also made of brick and vaulted. The stone foundation walls do not draw water, which occurs below the foundation level. The water table level was confirmed by geotechnical boreholes and exploratory excavations made during the site reconnaissance. The foundations do not require additional heavy waterproofing, due to the properties of the material from which they were made; stone does not draw water hygroscopically, any moisture is solely related to improper drainage of rainwater.

Photo 4. Vaulted basement of the Kossak Manor Granary building

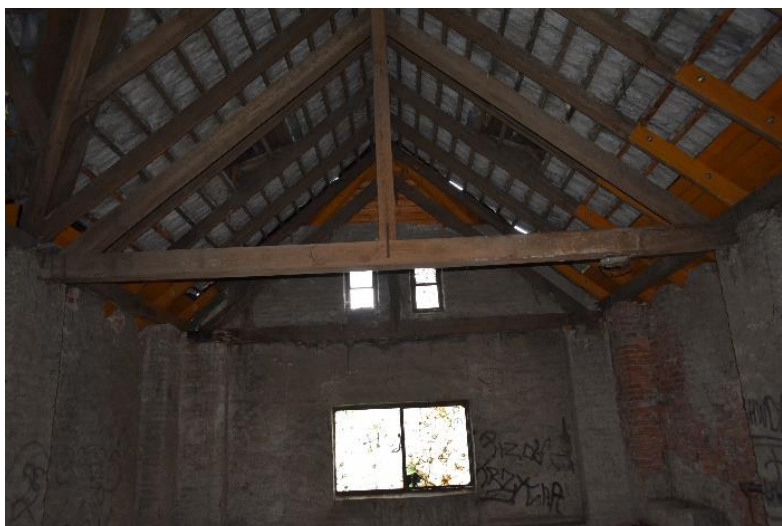
Segment D: It has a ceramic slab on steel beams and a single-level hanging roof truss (Photo 6). Wooden structural elements did not show any damage during visual inspection and macroscopic examinations; however, after sampling, it turned out that they are significantly damaged internally (Photo 7).

Photo 6. Roof truss in segment D

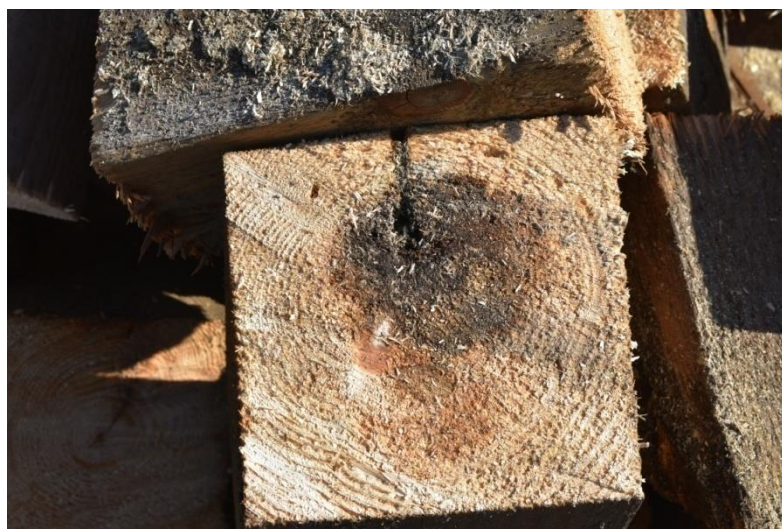
Photo 7. Internal damage to the wooden element

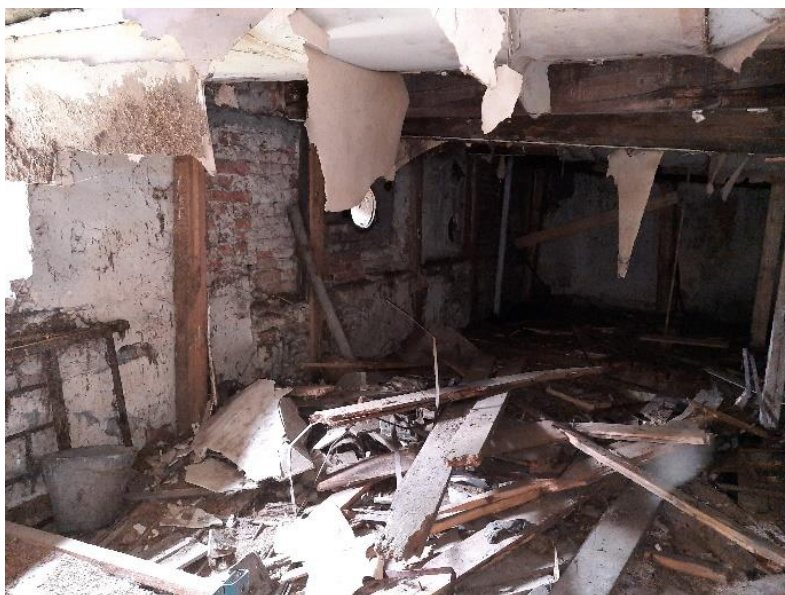
During the on-site inspection and exploratory excavations, a number of structural damages and problems were identified, such as the destruction of wooden ceilings (Photo 8), damage to stairs (Photo 9), pillars (Photo 10), corrosion of wooden and metal elements, and local frost damage to bricks in areas affected by leaks or rainwater penetration (Photo 11).

Photo 8. Damaged wooden ceiling

Based on the conducted technical assessment, the building has been deemed to be in an emergency condition. Urgent implementation of necessary repair works has been recommended, including but not limited to roof replacement or repair, repair of ceilings (or their replacement associated with the planned change of building function - changes related to fire safety). Drying and repair of load-bearing walls, repair of cracked vaults on the ground floor, and strengthening of foundations to equalize pressures on the ground and thus limit the possibility of future cracks and damage to the building are also recommended (it should be taken into account that there are several different segments from A to D).

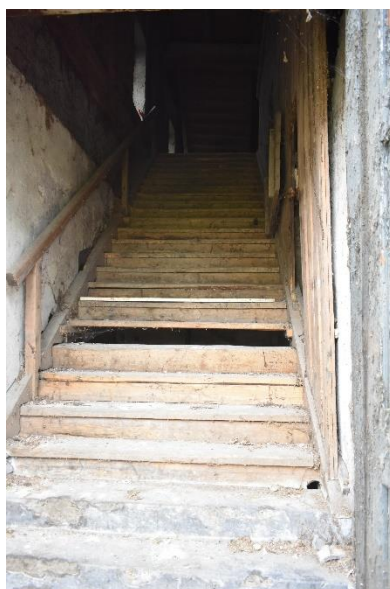
Photo 9. Damaged wooden stairs

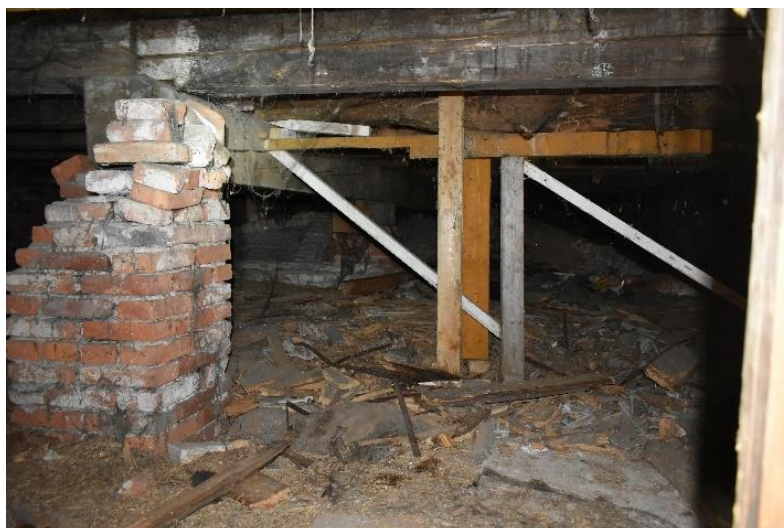
Photo 10. Damage to the ceiling and its supports – pillars

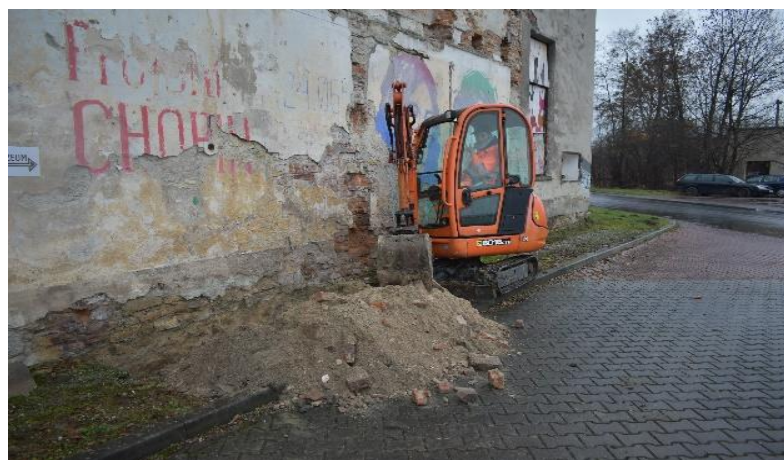
Photo 11. Damage to external walls
