## REVITALIZATION OF A RESIDENTIAL-COMMERCIAL TENEMENT HOUSE IN MYŚLIBÓRZ AT RATUSZOWA STREET 11

### Abstract

The article discusses the current issues related to the revitalization of a building fully protected by conservation laws. The work covers a wide range of activities involved in the construction process aimed at fully restoring the functional qualities of historical architecture, while also ensuring the proper exhibition of preserved cultural heritage elements. The analyses, study materials, and design works carried out enabled the implementation of construction works for this unique building. To illustrate the research problem, the method of a selected case study was used, and design activities (Research Through Design) were incorporated into the research process. The subject of the study is a specific building – a monument, which also serves as a representation and an example of a neglected spatial structure within a historic inner-city complex. Based on the analysed case, general conclusions were formulated that are helpful in preparing diagnostics and design works related to the revitalization of historical buildings in poor technical condition.

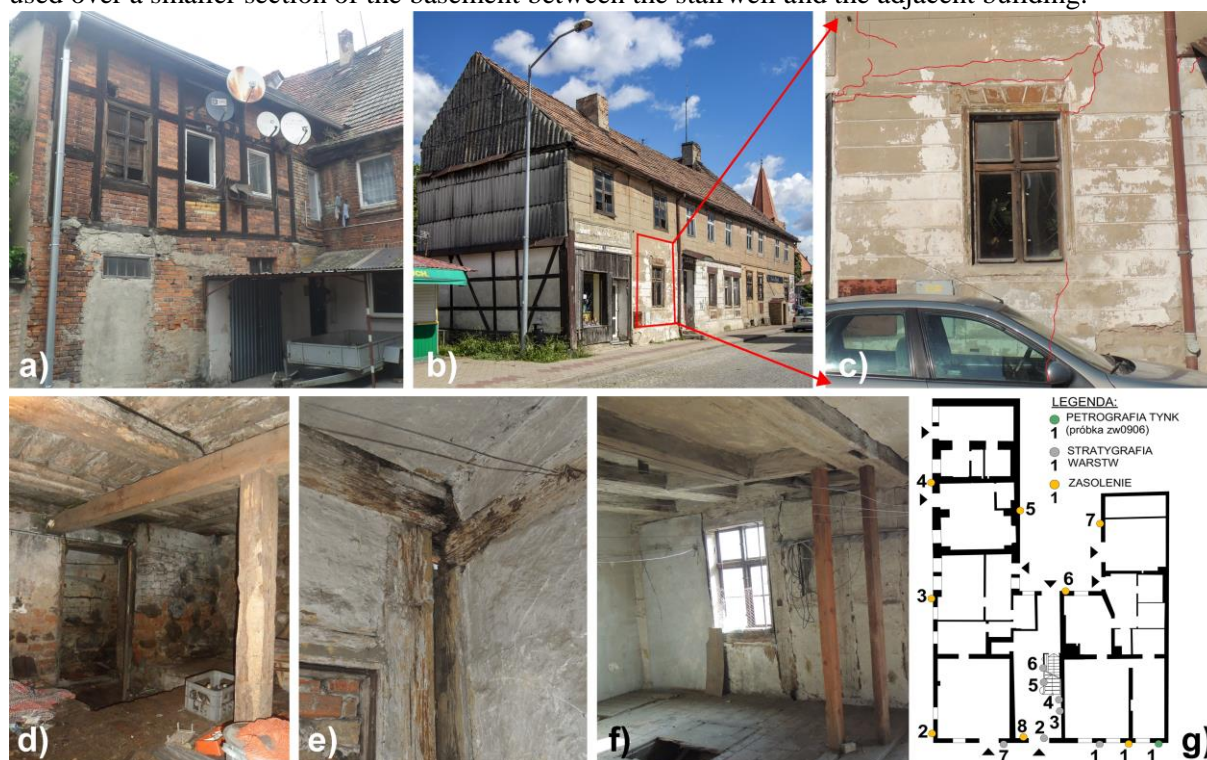
The individual walls have varied external finishes: smooth plaster on the elevation facing Mariacka Street (Fig. 4b-c); weak clay-lime plaster on the entire elevation facing the courtyard, and asbestos cement on a section of the gabled elevation of the southern outbuilding (Fig. 4b). The external

walls of the northern outbuilding are constructed similarly, but the gable end of the outbuilding is entirely finished with a cement-lime render, while the longer wall facing the courtyard was originally left unplastered (Fig. 4a).

Fig. 4. Condition of the Building's Structural Elements: a) Northern Wing annex– Visible Deformations of the Timber Frame Structure, Secondary White Window Joinery, b - c) Southern Wing annex – Cracked, Moist, and Discolored (Salt-Damaged) Exterior Plaster, Secondary Asbestos Sheet Finish on the Gable, Secondary Extension Adjacent to the Internal Stairs Leading to the Basement (Marked with a Red Arrow ), d) Main Building Basement – Moist Stone-Brick Walls, Wooden Ceiling with Visible Signs of Insect Infestation, e) Ground Floor of the Southern Annex – Separation of the Timber-Framed Wall Construction, f) First Floor of the Northern Annex – Emergency Shoring of the Wooden Ceiling with Props, g) Ground Floor Plan – Sample Collection Points for Analysis. Source: Author's Documentation and Photos

The identified emergency state of the building was largely due to numerous damages associated with uneven settlement. Key causes included unfavorable ground-water conditions and increased vehicular traffic in the immediate vicinity of the building, which caused vibrations transmitted throughout the entire structural system. Additionally, the lack of proper moisture-proof insulation significantly contributed to the deterioration of the timber foundations, posts, beams, and purlins (Fig. 4a). There was significant moisture damage and mold growth in the basement walls (Fig. 4d). As a result, there were very noticeable damages and deformations to both the internal and external timber-framed walls (Fig. 4e). The damaged plaster finishes on the walls, with visible cracks, fissures, and changes in color, reflected the condition of the wooden structural elements (Fig. 4b-c). Large areas of the façade exhibited moisture damage, atmospheric staining, and material loss (plaster, brick, wood). Inside, the ceiling structures showed significant deformations and sagging (Fig. 4f). The variations in the support levels of the ceiling beams were substantial, reaching nearly 30 cm. Most of the roof truss connections were loosened, and its elements locally exhibited signs of biological decay as well as minor cracks and looseness typical of aged wooden components.

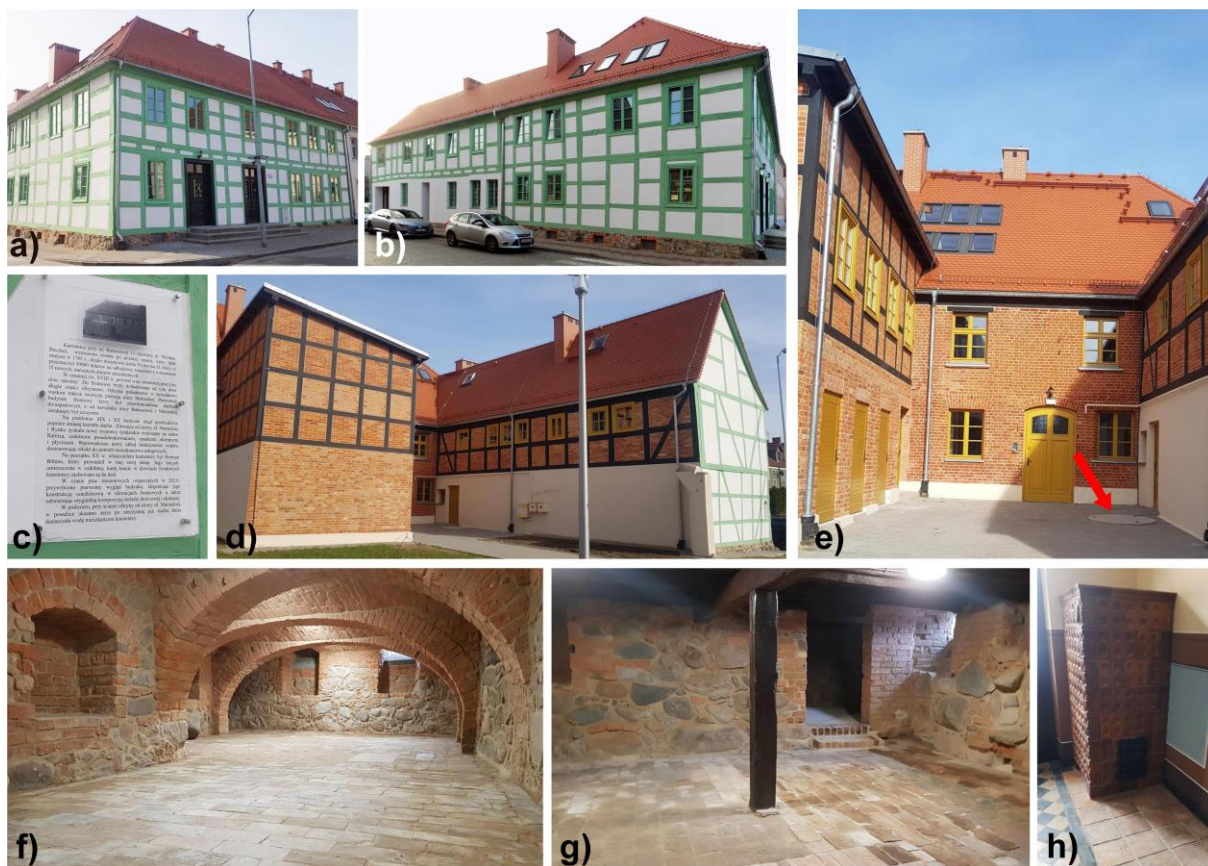
Fig. 6. The tenement house after the revitalization: a) the elevation on Ratuszowa Street and a fragment of the elevation on Mariacka Street, b) the elevation on Mariacka Street c) information board with a description of the building's history d) View of the annexes from the west side, e) View of the semi-open inner courtyard, with the red arrow indicating the trace of the deep well, f) Cellars under the southern part of the main body, g) Cellars under the northern part of the main body, vaulted with a wooden ceiling, h) Preserved ceramic stove set on a floor finished with original ceramic tiles. Source: authors' research and photographs

nr	Change
1	Change in the finishing method of the facade on the Ratuszowa and Mariacka street sides – the originally planned restoration of the bossage resulting from the building's reconstruction at the turn of the 19th/20th century was abandoned in favor of the original appearance with exposed half-timbering and a light green color scheme (according to the stratigraphy study - sample no. 1) (Fig. 6a-b). The originally proposed façade color scheme is shown in Fig. 5a-b.
2	Omission of the planned drywall covering of the wooden ceiling above the cellar after its cleaning, sandblasting, impregnation, and painting; the ceiling remained exposed from below and intended for exposure (Fig. 6g).
3	Abandonment of plastering the interior of the cellars, leaving the brick and stone masonry threads of the walls and ceilings fully exposed (Fig. 6f-g).
4	Preservation, on the ground floor in the main hall, of a witness in the form of a fragment of the existing ceramic tile floor – the tiles were reversed, cleaned, and re-grouted, with chipped elements replaced by identical ones sourced from the dismantling of the floor finishing on the first floor in the southern wing (above the former carriage gate) (Fig. 6h).

5	Relocation and restoration of one of the three preserved tile stoves – the stove from the living room on the first floor was moved to the hall on the ground floor, while the remaining two stoves were dismantled and handed over to the Investor (the original conservation work program had planned to preserve all three stoves) (Fig. 6h).
6	Abandonment of the complete fire protection enclosure for the public staircase on the ground floor (main hall) and the structural elements of the roof truss in the attic of the main building, for their exposure (Fig. 7a-b)
7	Removal of the secondary extension with door (Fig. 4b) at the basement exit from Mariacka Street.

In addition, based on the conclusions of complementary research, it was decided to commemorate the former owner of the tenement and to preserve one of the original pieces of technical infrastructure. It was established that the initials "HB" on the preserved metal grille of the external door on the ul. Rynkowa side belonged to the building's owner, Herman Böhme, who operated his shop there from the early 20th century (Fig. 7c). The grilles with the former owner's initials were also placed on two other newly created doors, modeled after the originals, installed on the facades facing the streets. In turn, an information board with the history of the monument has been installed on the gable wall of the south outbuilding (Fig. 6c). During the construction work, archaeological research uncovered a historic dug well with a brick casing. The decision was made to preserve the well as a historical witness, and it was conserved and protected with a concrete slab at ground level (Fig. 6e).
