ANALYSIS OF THE IMPACT OF MOISTURE AND BIODETERIORATION ON THE ASSESSMENT OF THE TECHNICAL CONDITION OF HISTORICAL BUILDINGS

Abstract

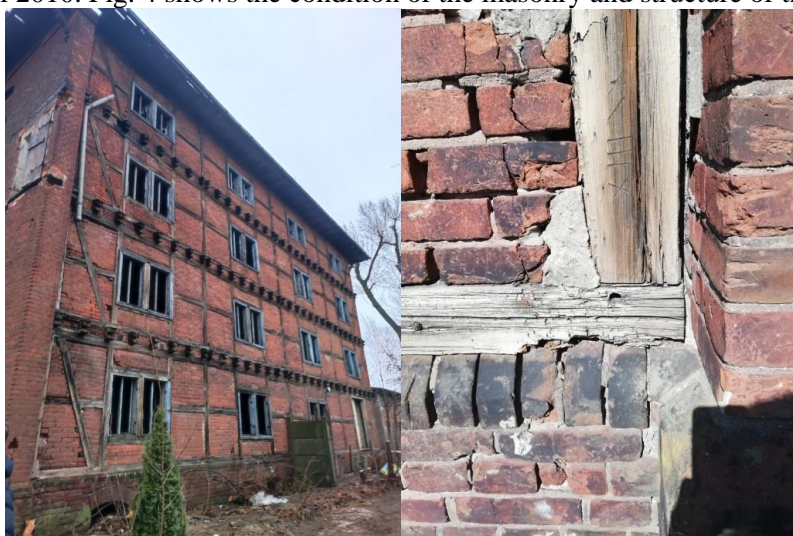
Fig. 4. Elevation of the retrofitted building, condition of the masonry samples author archive

The article presents excerpts from an expert opinion prepared for the pre-design phase of a historic building located in the sports and recreation complex in Gniezno. The aim of the study was to assess the infestation of elements by microorganisms, domestic fungi and insects - technical wood pests. In addition, to propose measures for the safe renovation of the building elements with the indication of the scope of impregnation and de-fungation works or the exclusion of renovation measures. The half-timbered building has a basement and a reinforced concrete staircase. Wood is the predominant material in the construction of the building. Constructed around 1900, the building is unoccupied and gradually deteriorating until 2010. Fig. 4 shows the condition of the masonry and structure of the first storey.

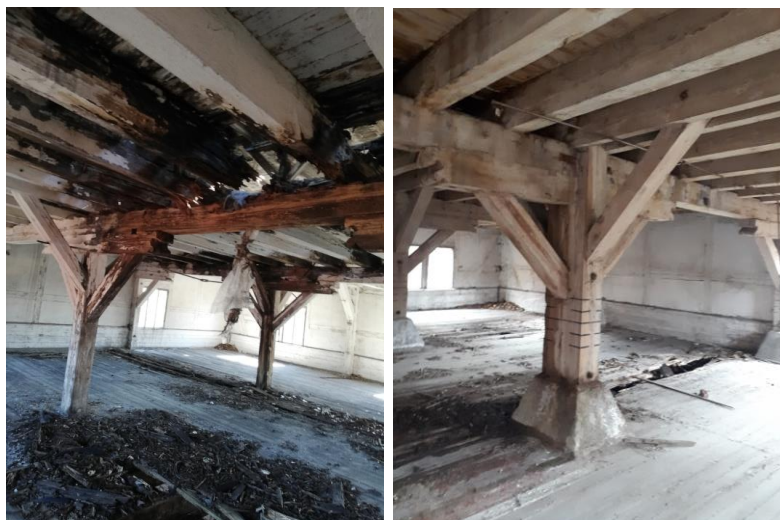
Dampness was observed over a long period of exposure, there are clear degraded elements on the roof truss elements in the roof slope section in the nave and on the lower floors of the building in the nave and along the slope line. Traces of fire are visible in the outer nave on the third storey (fig. 5).

Fig. 5. Structural elements damaged by fire, uncontaminated section of building structure author archive

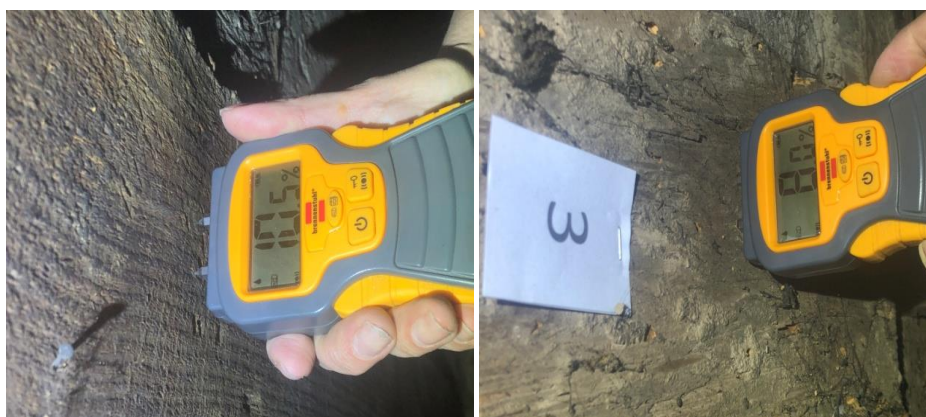
Wood moisture measurements were carried out on selected elements both on the outside of the building and on the internal elements (Fig. 6).

Fig.6. Measurements of moisture content of construction elements selected for mycological tests author archive

The location of the measurement points is marked on the floor drawings of each storey. The moisture content of the selected elements (visually selected representative locations for the analysis) was as follows: 8-10,5%.

According to the given criteria, the tested elements in the most sensitive places showed a condition bordering on dry/humid. The internal temperature was not measured during the site visit, as this would
