TECHNICAL CONDITIONS OF DIAMOND VAULTS IN POLAND

Abstract

Diamond vaults represent the greatest achievement of the Gothic architecture. Only about 130 buildings with such vaults have remained to our times, including 30 buildings in Poland. Diamond vaults are less stiff than rib vaults, and consequently more prone to damage. This paper presents technical conditions of diamond vaults in Poland, their typical damage and repair methods.

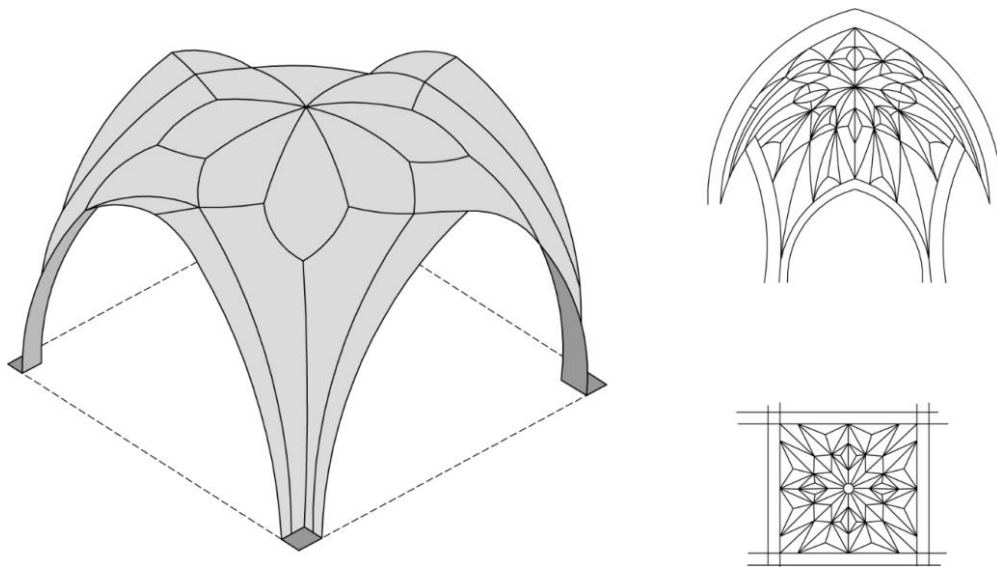
Fig. 2. Diamond vaults

The design of a diamond vault did not include ribs and had vault cells alternately sloped against the vault plane (Fig. 2). Such placement of vault cells formed sharp ridges with high stiffness, which replaced ribs. These ridges, also known as wires [8], or vault ridges [9] were shaped to form solid lines corresponding to the alignment of ribs in the arrangements similar to rib vaults. The most common ridges had stellar or net arrangement (Fig. 3). Geometry of diamond vaults resembles barrel or sail vaults, rarely pointed arch vaults. Diamond vaults are usually more flattened compared to Gothic stellar vaults.

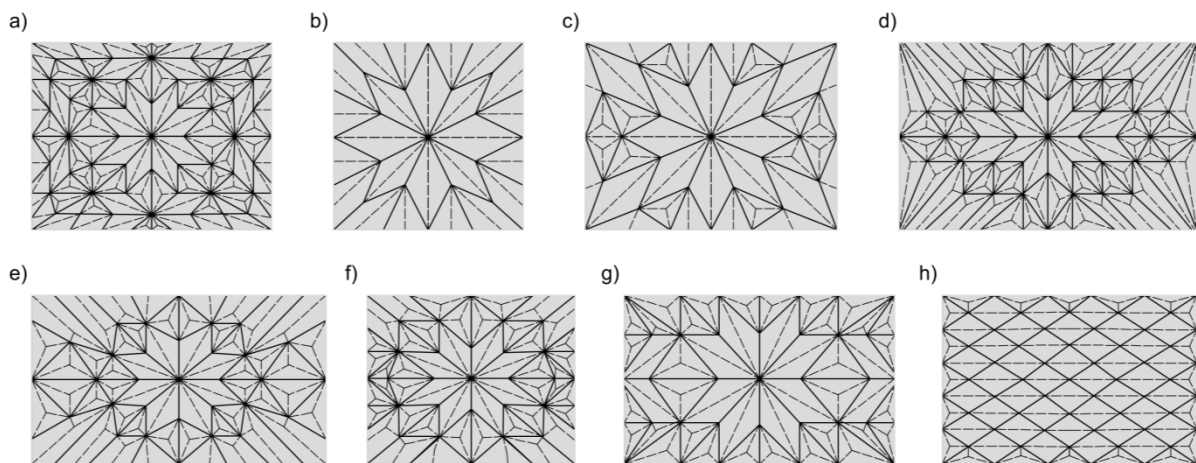
Fig. 3. Arrangements of ridges in diamond vaults: a) Gdańsk, St. Mary's Basilica b) Gdańsk, St. Catherine's Church, c) Gdańsk, St. Peter and Paul's Church, d) Vilnius, Bernadine Church, e) Kętrzyn, St. George's Basilica, f) Łomża, Cathedral of Archangle Michael, g) Barczewo, St. Anne and Stephen's Church, h) Olsztyn, St. Jacob's Basilica

Besides main ridges, diamond vaults also have intermediate ridges (marked with dashed lines in Fig. 3). They divide space between main ridges into smaller fields and provide their stiffness.

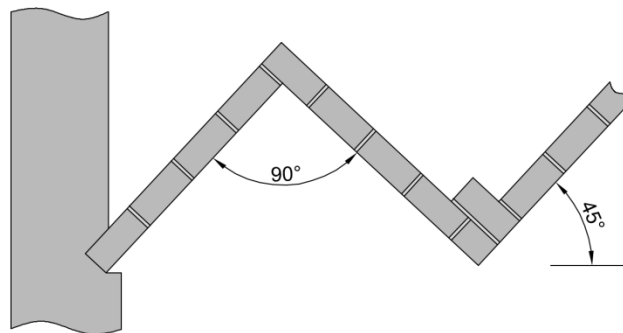
Fig. 4. Methods of shaping ridges of diamond vaults

Diamond vaults were usually made from brick or stone. An inclination angle of vault cells against the level was determined by a type of the applied material. This angle in brick vaults is usually 45° , and in the majority of stone vaults it is even greater. Diamond vaults in Poland were usually made of brick, whereas the Czech and Saxon vaults were usually made of stone responsible for sharper ridges. A thickness of diamond vaults is generally equal to a half of the brick. Sometimes, they had a thickness of one brick at main bottom ridges by placing adequately masonry units (Fig. 4).

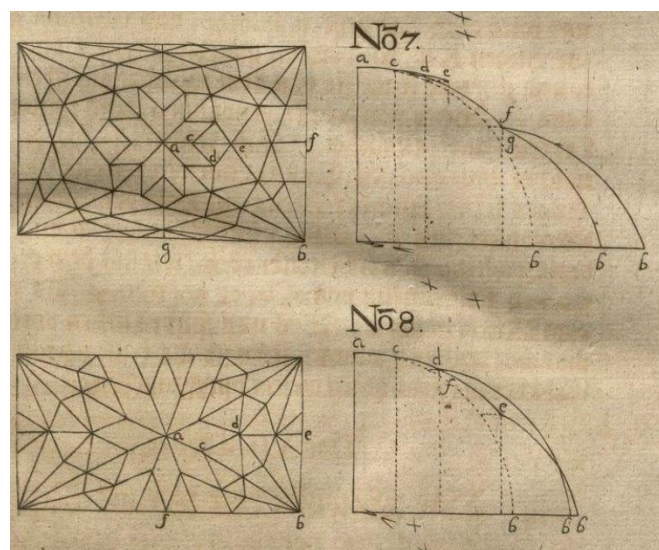
Fig. 5. Drawings of diamond vaults in St. Mary's Basilica in Gdańsk by Ranisch [11]

Gothic vaults were formed by master builders obligated to keep their work in a professional secret. The development of new ceiling structures led to a decreasing need to build such vaults, and their construction principles became forgotten [10]. Researchers have been debating for years about old techniques of performing diamond vaults. A method of their building was researched by Ranisch [11] already at the end of the 17th century (Fig. 5).

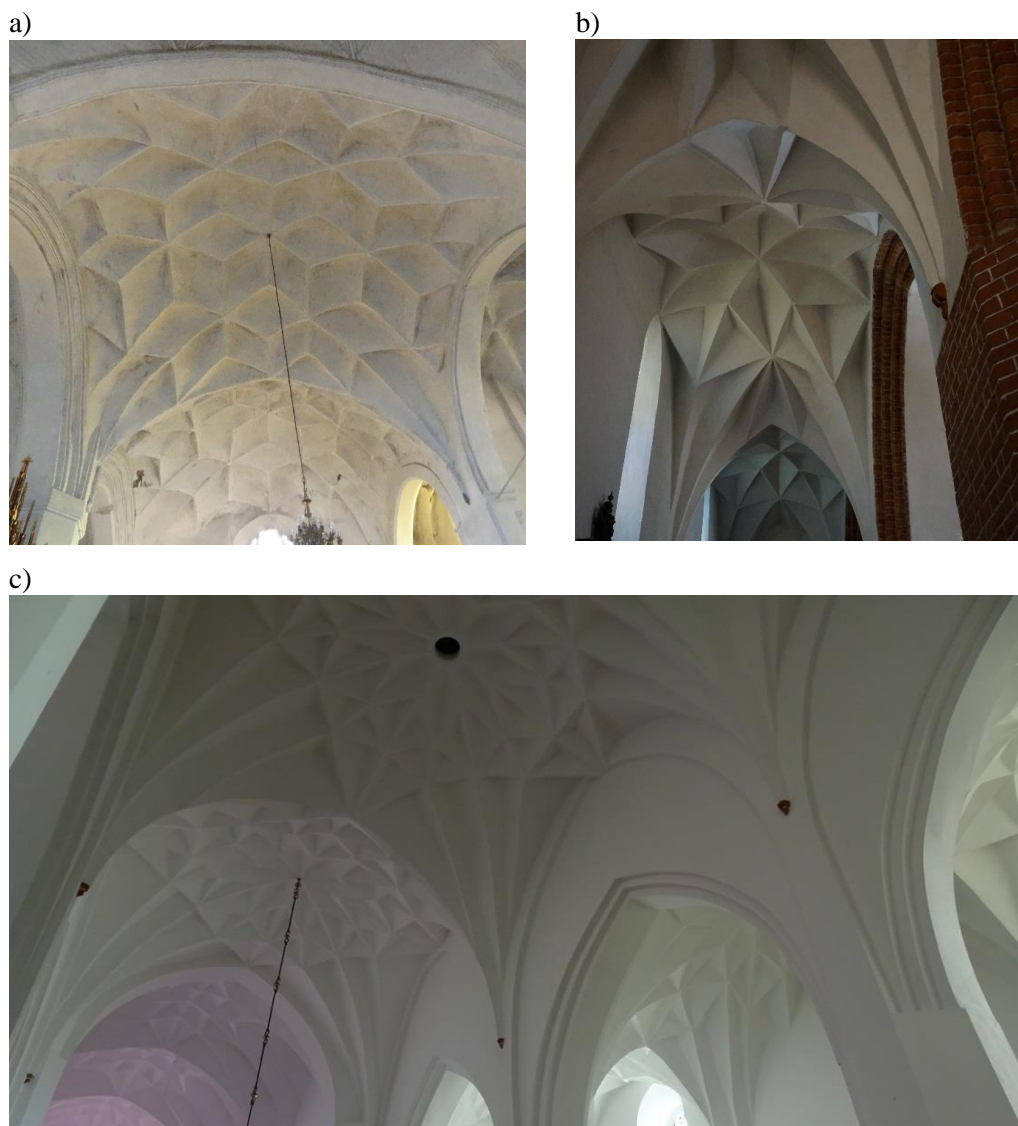
Fig. 9. Diamond vaults performed by the master builder Matz: a) St. John's Church in Malbork, b) St. Joseph's Church in Morąg, c) Collegiate Basilica of St. John in Kętrzyn

A master builder Matz from Gdańsk was very active in Pomerania and Warmia and Masuria. He vaulted St. John's Church in Malbork in ca.1500 r. (two large vault fields – Fig. 9a, and narrow vaults over window niches have remained until today), aisles in St. Joseph's Church in Morağ in 1503 (Fig. 9b), and a church in Marianka and Collegiate Basilica of St. John in Kętrzyn in 1515 (Fig. 9c). The latter church is exceptional as the diamond vaults were used over all naves, not only aisles.

Compared to Gothic rib vaults, diamond vaults are less stiff. Their makers were probably aware of that fact as diamond vaults were not generally formed at spans exceeding 7.5 m. Therefore, diamond vaults are usually observed above aisles in churches. Collegiate Basilica of St. John in Kętrzyn is an exception as all naves were vaulted in that way (Fig. 9c).

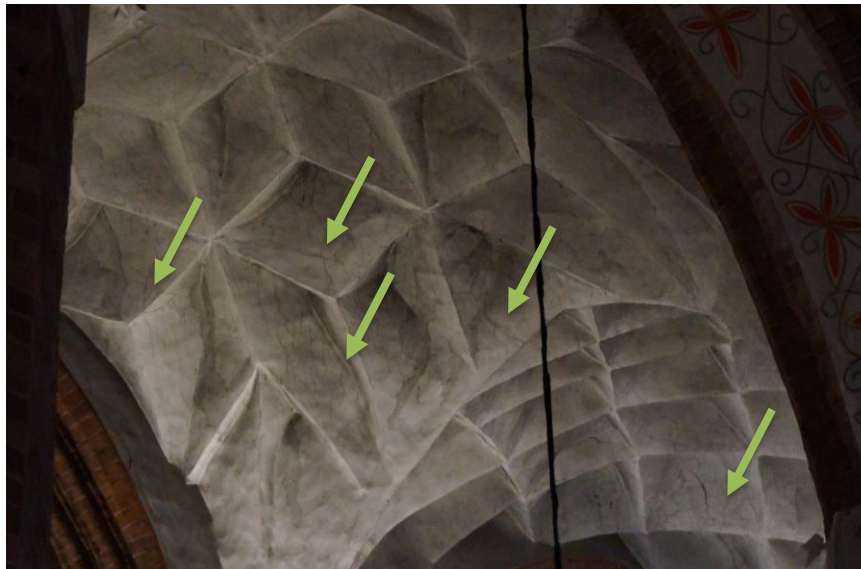
Fig. 22. Cracks in diamond vaults in St. Jacob's Basilica in Olsztyn

Technical conditions of diamond vaults in structures in Poland are usually good. Sometimes plasters are damaged as in case of St. Jacob's Basilica in Olsztyn (Fig. 22).

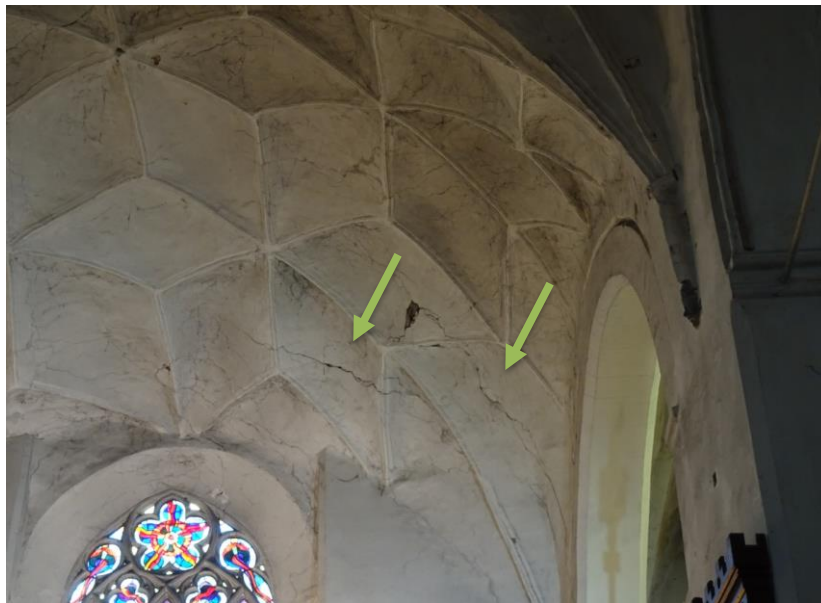
Fig. 23. Cracks in diamond vaults in St. John's Church in Malbork

However, some buildings face structural problems, as in St. John's Church in Malbork (Fig. 23÷27). A source of these problems is rooted in the past. During the 1st Polish-Swedish war, the enemy army wanted to blow up the wall around the nearby, then Polish, castle in Malbork. They dug a miner tunnel running through the bank at the bottom of the church, on the side of the river Nogat. The tunnel, however, did not have a strategic meaning during attempts to seize the castle, but in fact it weakened the bank and foundations of the church. After a short time these conditions led to the structural collapse. The western wall of the church collapsed with the last bay (then the church was shortened by that last bay). The roof

fire in 1649 caused serious damage to the vaults. In some bays they even partially collapsed. It should be also mentioned that Prussia regulated the water level in the river Nogat in the years 1900-1917. Consequently, walls of the Great Refectory in the middle ward collapsed. It could also affect the foundations of St. John's Church. The war in 1945 destroyed roofs and the top (wooden) floor of the tower and some vaults. Town buildings surrounding the church were demolished, which could also affect its stability. Currently, works are performed to restore the proper technical conditions of diamond and rib vaults. Cracks are stitched and injected, and plasters are restored (Fig. 28). The most damaged vaults have been strengthened from the top with the FRCM system (Fig. 29). This type of strengthening seems to be the most appropriate for seriously damaged vaults [23, 24].

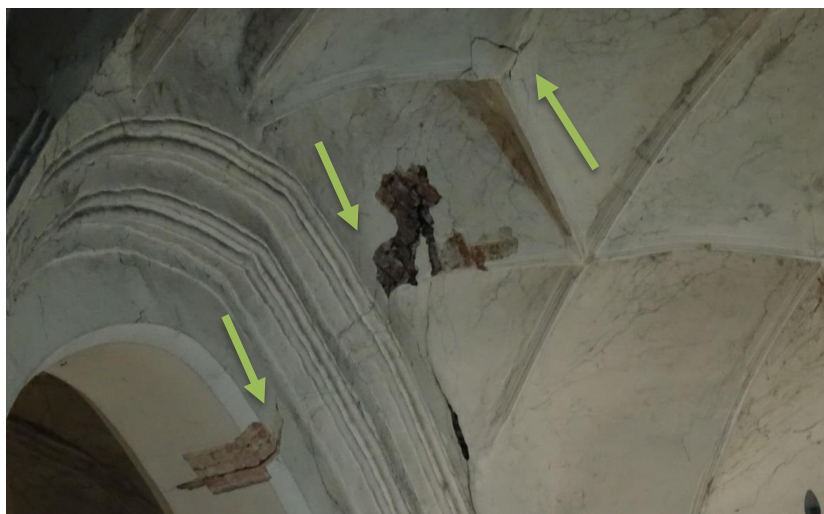
Fig. 24. Cracks in rib vaults in St. John's Church in Malbork

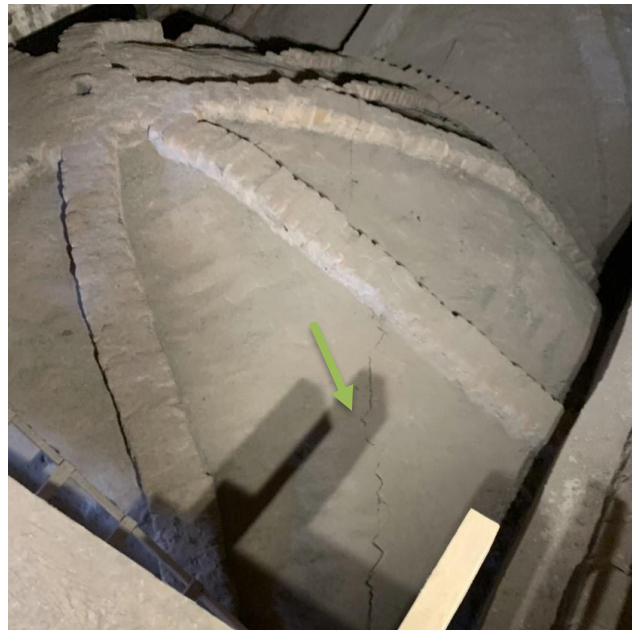
Fig. 25. Crack in rib vaults in St. John's Church in Malbork (photo by M. Jackiewicz)

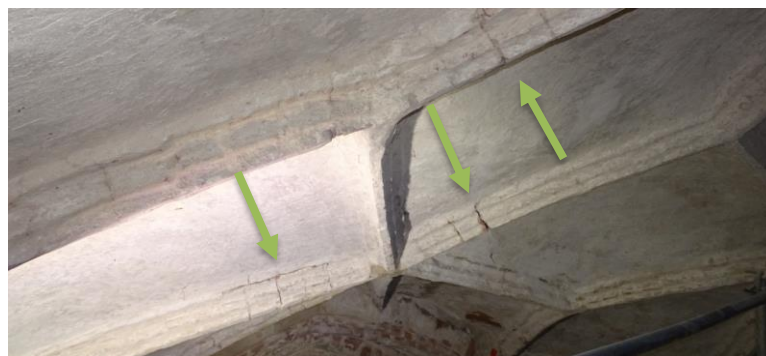
Fig. 26. Cracked ribs in rib vaults in St. John's Church in Malbork

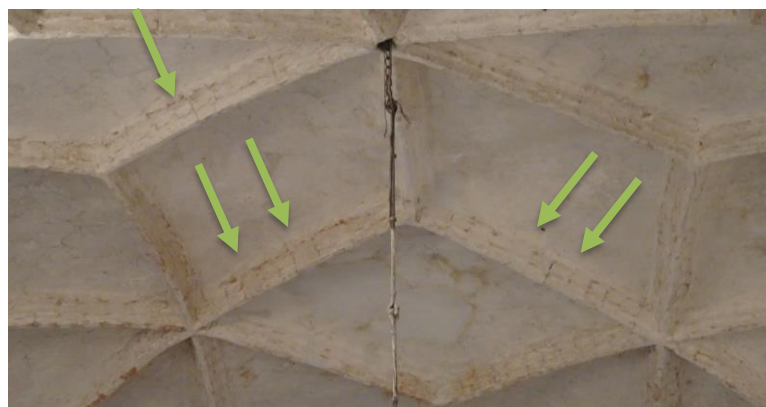
Fig. 27. Cracked ribs in rib vaults in St. John's Church in Malbork

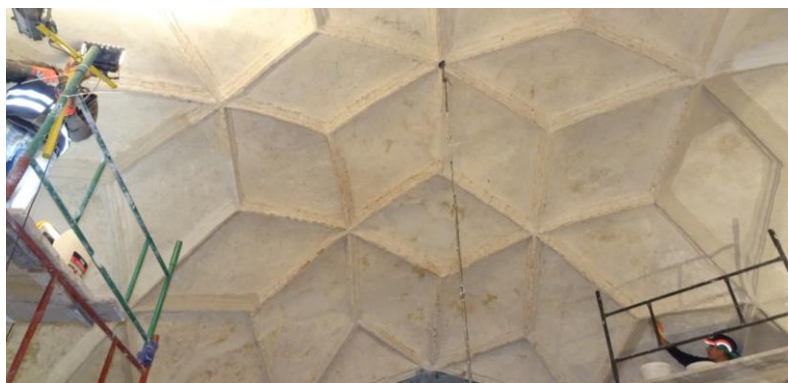
Fig. 28. Restoration works performed underneath the rib vaults in St. John's Church in Malbork

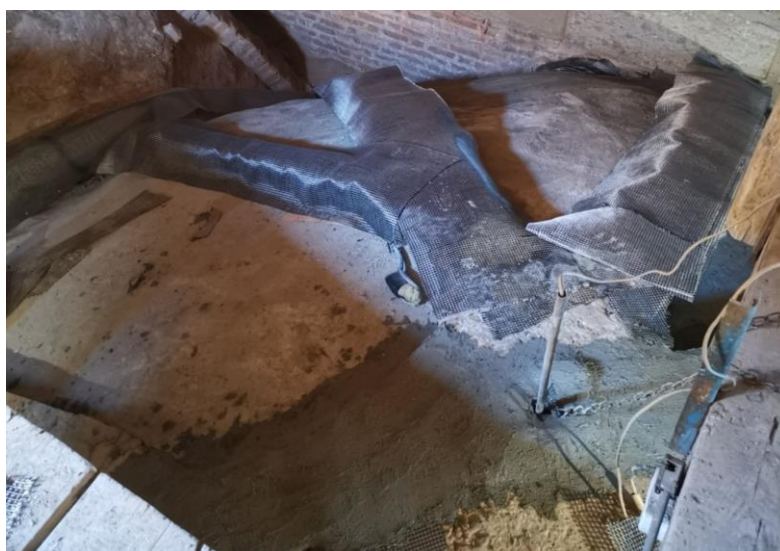
Fig. 29. Application of the FRCM system to top ribs in the rib vaults in St. John's Church in Malbork (photo by M. Jackiewicz)

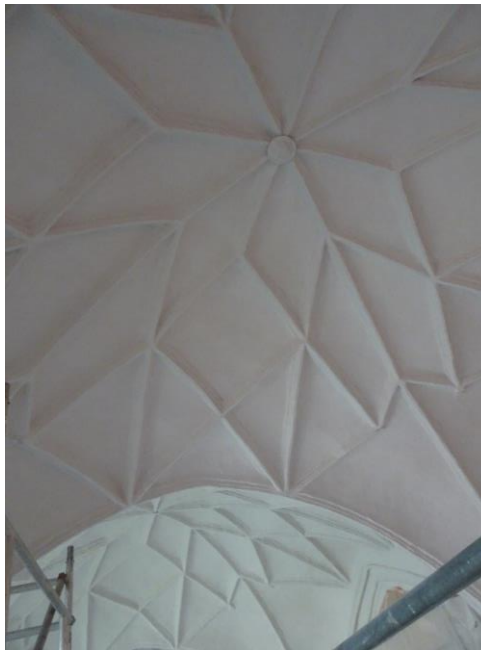
Fig. 32. Restored rib vaults in St. John's Church in Malbork

Restoration works in narrow window niches with diamond vaults revealed painted wall decorations from the medieval period (Fig. 30). They were also restored (Fig. 31). Fig. 32 shows restored rib vaults.
