## THE RENOVATION OF THE FORMER ZAMOŚĆ ACADEMY BUILDING IN ZAMOŚĆ IN THE CONTEXT OF RENOVATION AND RESEARCH CHALLENGES

### Abstract

Keywords: renovation, Academy in Zamość, heritage, reconstruction

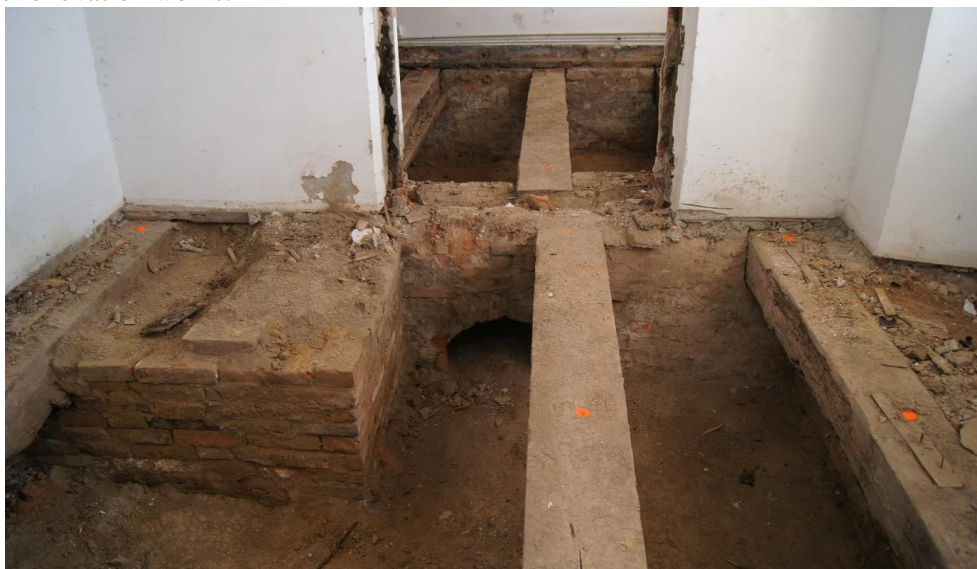
Fig. 3. Visible ventilation opening between the rooms of the ventilated floor and the beams/joists of the floor, photo by K. Janus, 2021

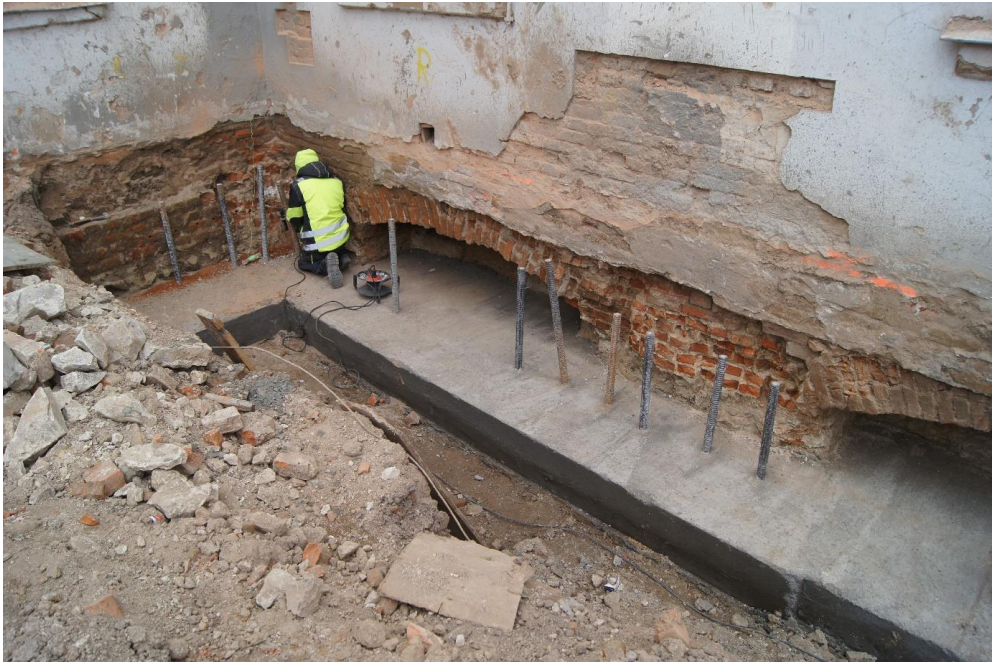
The academic courtyard originally featured two open arcade walls at the ground level. This was not a typical solution for that period; however, no information could be found about an alternative layout. The courtyard arcades were bricked up in the 19th century by the military. Their traces were discovered by Professor Zin in the 1970s [4]. During the current renovation, the removal of 19th-century infill and the restoration of the arcades were planned (Fig. 6, 7). The original columns were constructed on a point foundation, and the arcades were additionally supported by a brick arcade (Fig. 4).

Fig. 4. North-East corner of the courtyard with visible original point foundations and brick arch during reinforcement works on micropiles, photo by K. Janus, 2023

The work on the reconstruction of the arcades primarily involved strengthening the wall structure and the foundation of the arcade columns. The adopted solution included the use of micro-piles in tubular shafts of 10.5 meters in length, as well as reinforced concrete (Fig. 4). Additionally, spaces for reinforced concrete pins were cut between the arcades (Fig. 5) to relieve the load on the entire structure. The execution of this construction was a significant intervention in the building's structure; however, the structural engineer's recommendation indicated that such actions were absolutely necessary. Therefore, the only feasible action for the researchers was to thoroughly document the elements before they were modified.

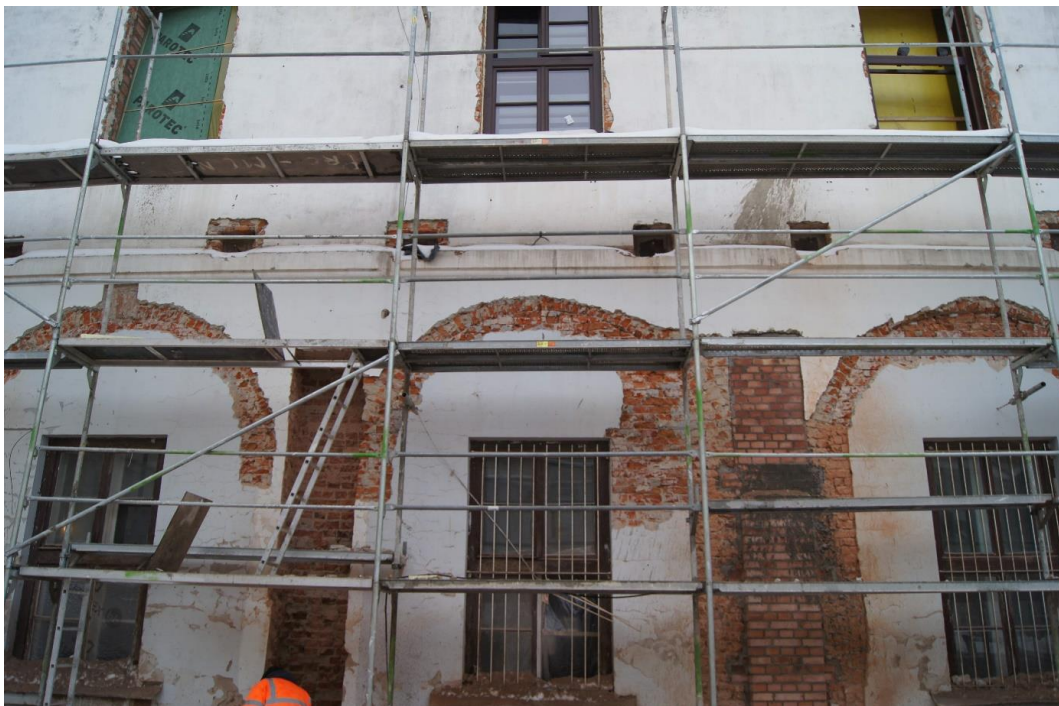
Fig. 5. Arcades during reconstruction, with the red arrow indicating the locations of the grooves for wall reinforcement, photo by K. Janus, 2022

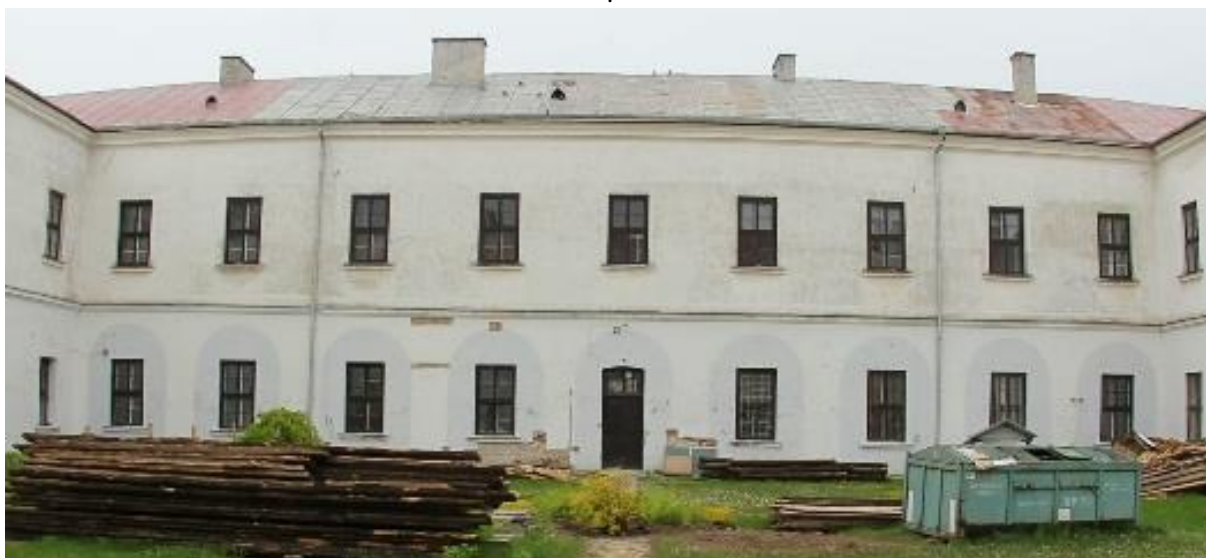
Fig. 6. View of the academy courtyard from the east before the renovation began, photo by K. Janus, 2021

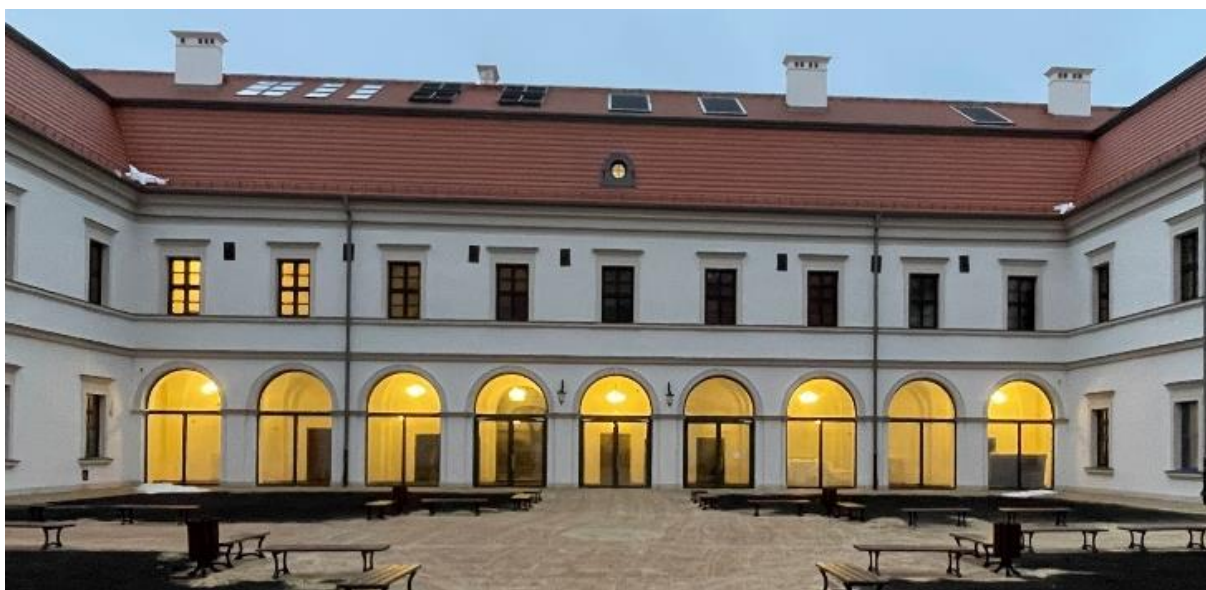
Fig. 7. View of the academy courtyard from the east after the renovation works were completed, photo by K. Janus, 2024

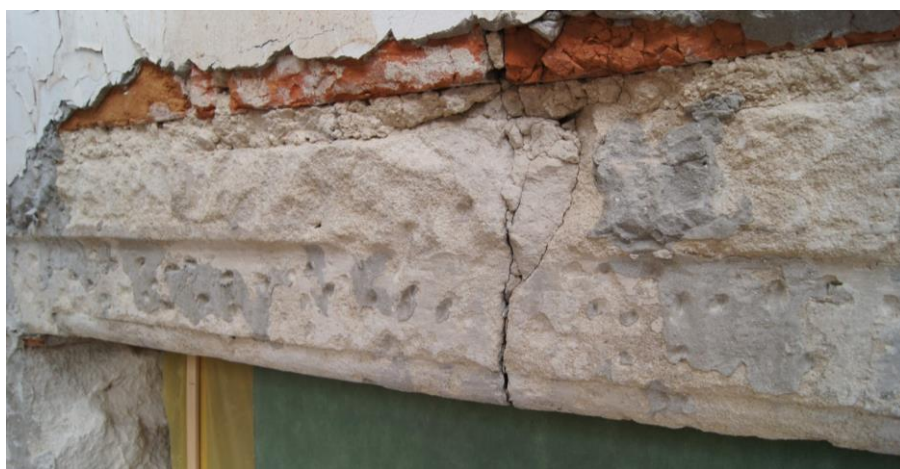
Fig. 8. Remains of the preserved stone lintel of the window surround in the courtyard, photo by K. Janus, 2024

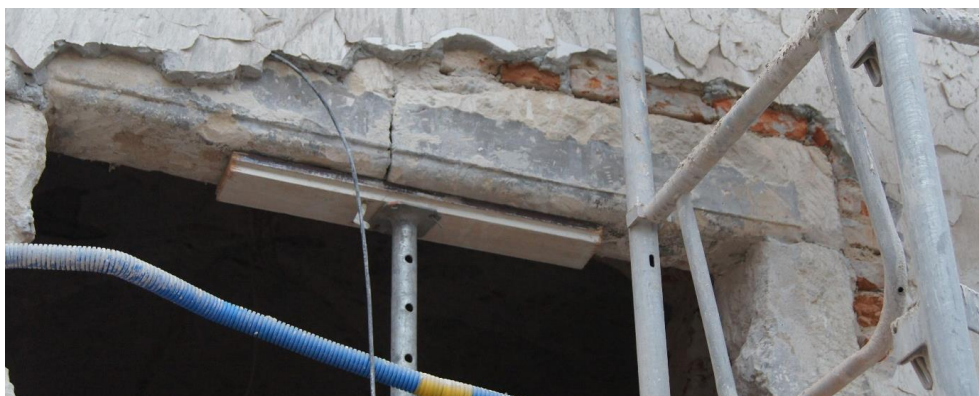
Fig. 9. Remains of the preserved stone lintel of the window surround in the courtyard, photo by K. Janus, 2024

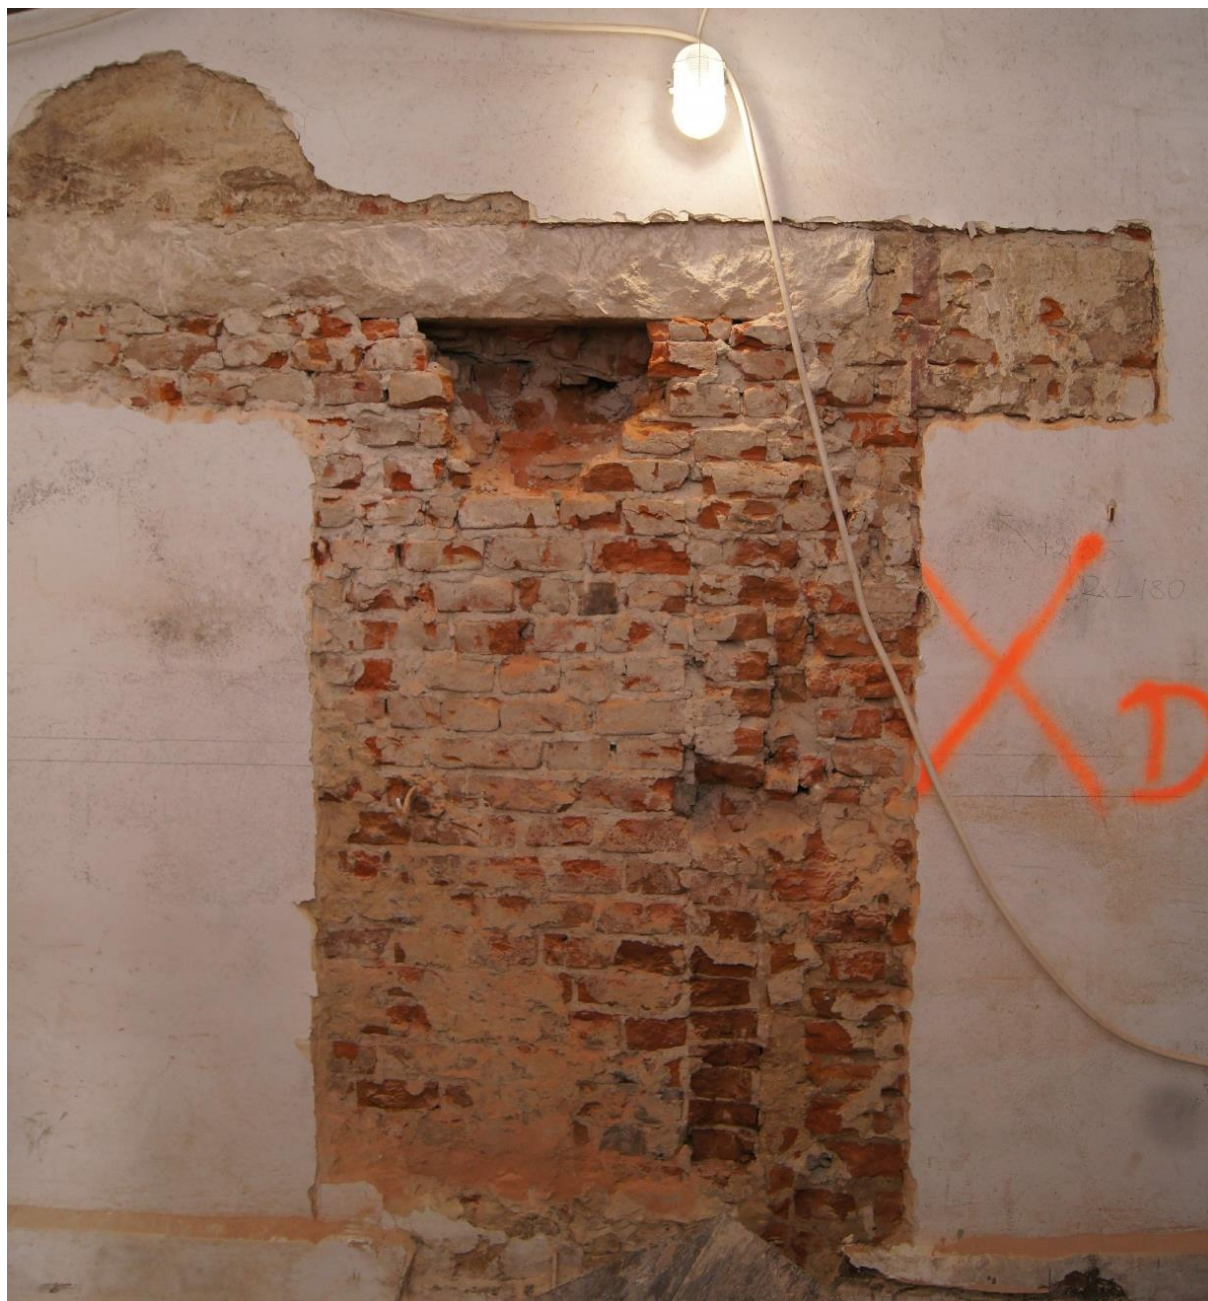
Fig. 10. Remains of the stone lintel beam, photo by K. Janus, 2024

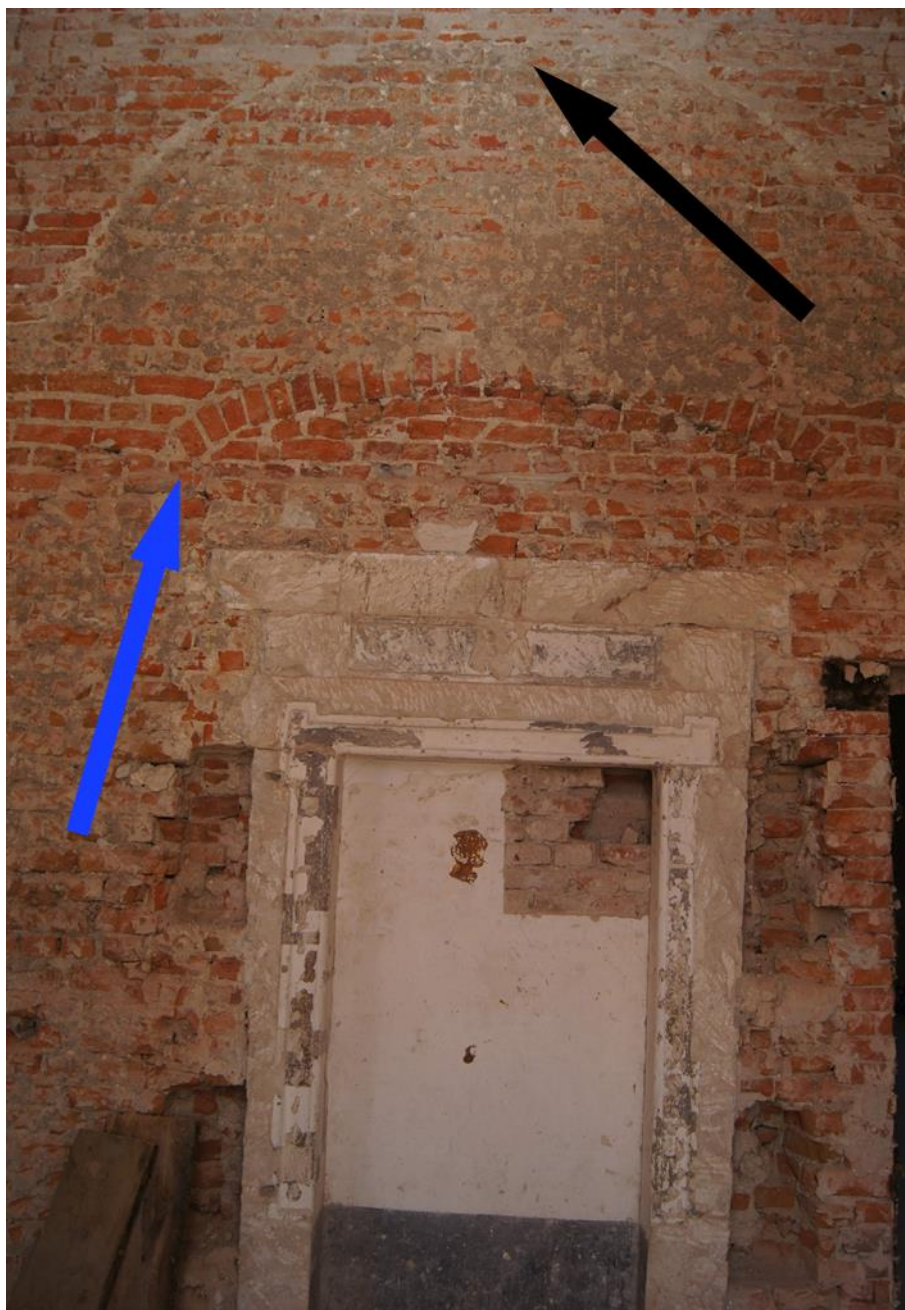
Fig. 11. Damaged stone portal with a visible relieving arch (blue arrow) and the negative of the vault (black arrow), photo by K. Janus, 2021

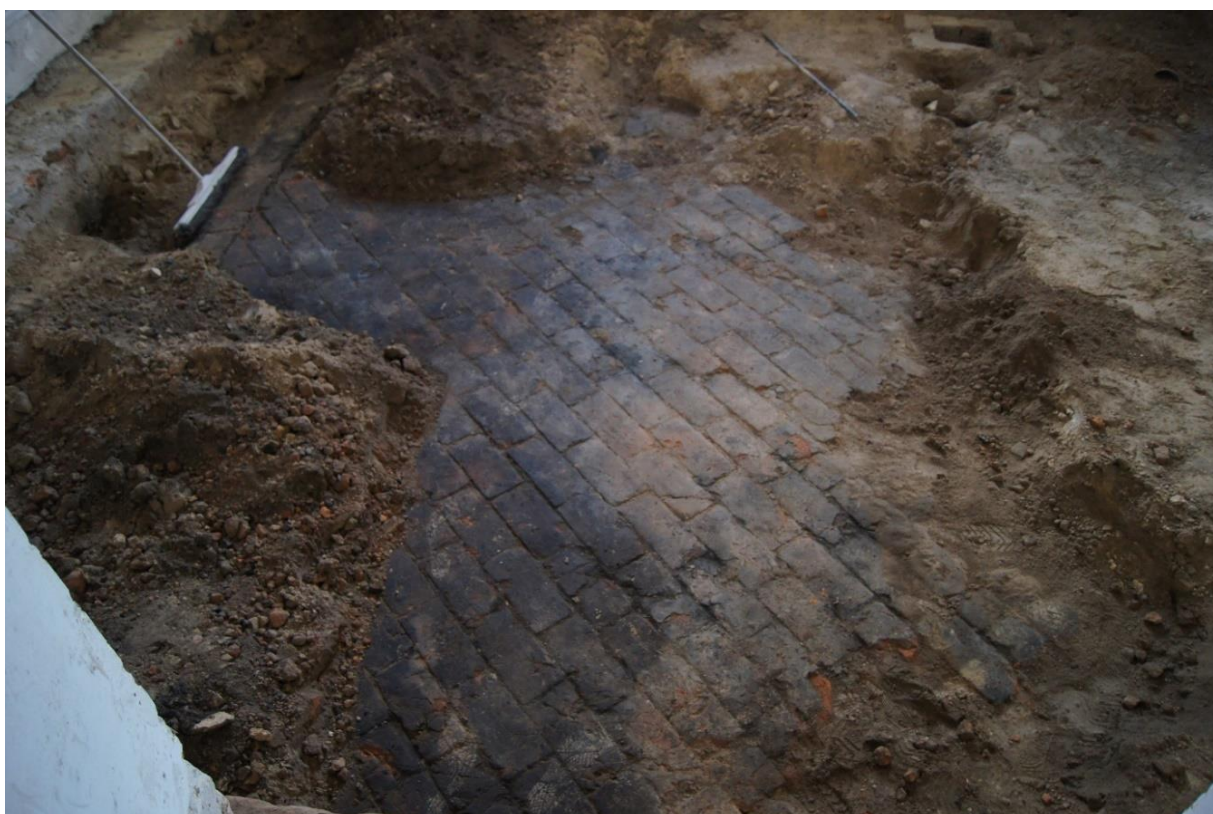
tiles (Fig. 12). These bricks were placed directly on the building's base, and their condition was incredibly poor. In many areas, they had sunk, with the brick structure cracked, and in some places, it was almost powdery and crumbling during cleaning. This floor had been supplemented at least several times with ordinary bricks laid vertically. At higher levels, additional brick floors were uncovered, arranged vertically in an alternating pattern and in a herringbone design. The most interesting floor was not associated with the academy building but with the older urban development (Figs. 12, 13) upon which the discussed building was constructed. It was made of bricks laid flat in a caro pattern with a border that delineated the external wooden wall of the original building. The surface of the floor bore traces of burning and melted lead, indicating the tragic end of the building. This floor could have functioned for only a few years, but it can certainly be stated that it is the best-preserved (and perhaps the only) 16th-century floor in Zamość.

Fig. 12. Floor of a residential/craft building from the 16th century, photo by K. Janus, 2020

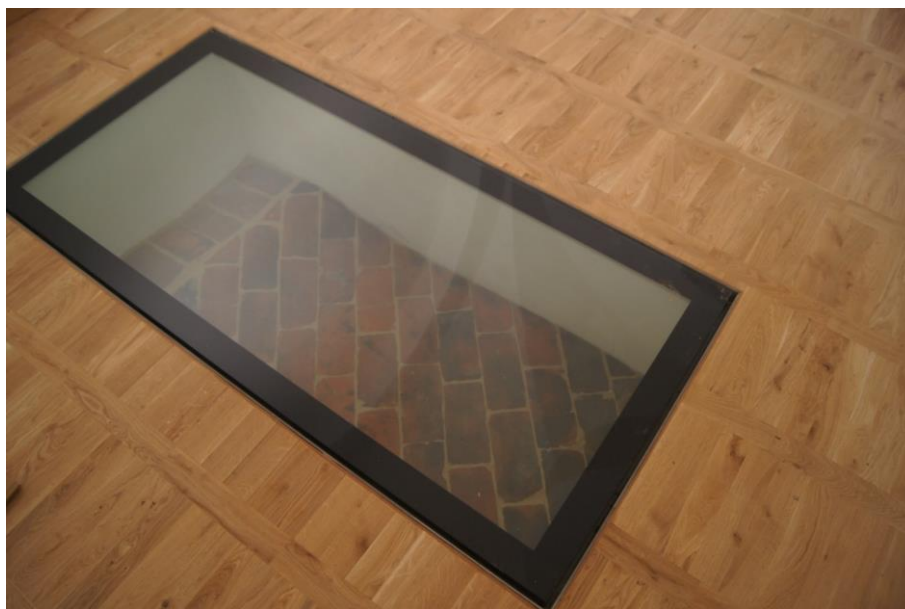
Fig. 13. Floor of a residential/craft building from the 16th century after cleaning and exhibition, photo by K. Janus, 2023

The uncovered historical floors, as the only elements, did not conflict with any aspect of the renovation works. From a research perspective, they allowed for determining the dimensions of the non-existent development preceding the academy building and for establishing older usable levels. Due to the uniqueness of the brick floor, a fragment of it was highlighted and covered with glass (Fig. 13).

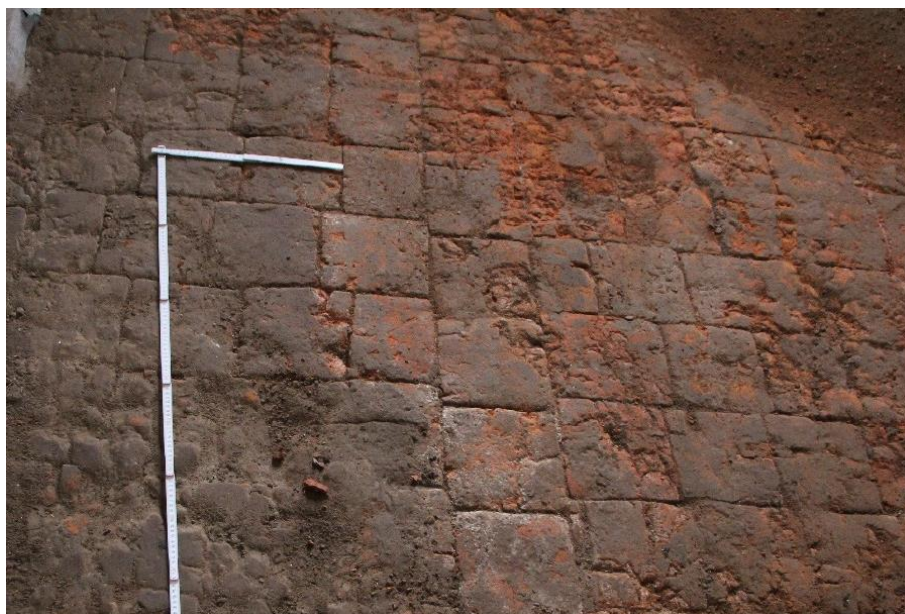
Fig. 14. Fragment of a brick floor from the 17th century in the corridor, photo by K. Janus, 2023

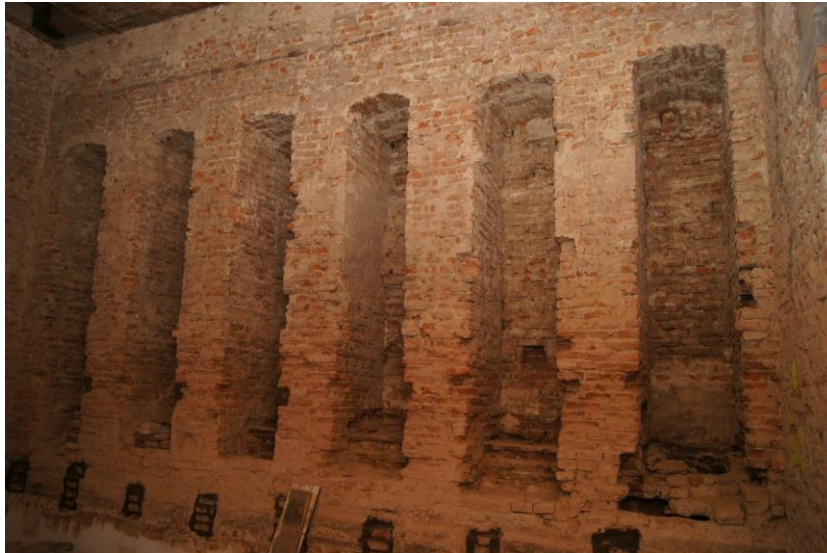
Fig. 16. Uncovered niches in the first-floor room, photo by K. Janus, 2022

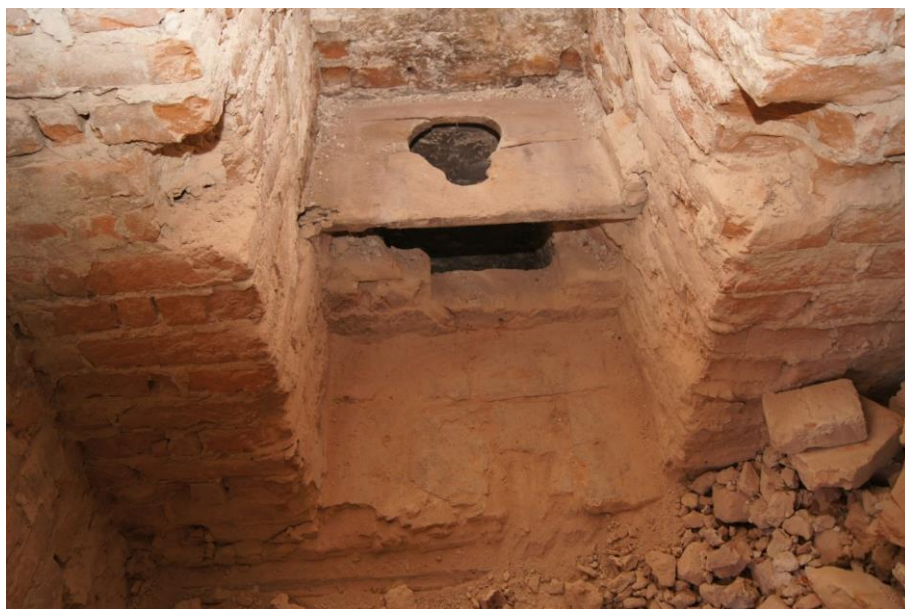
From a research perspective, the rarity of this find was undeniable. Such objects have not survived to the present day. The introduction of privies into the interior of buildings in the 17th and 18th centuries was, from a practical standpoint, inadvisable. Privies of this kind, lacking access to running water, sewage systems, and easily washable surfaces, were difficult to maintain and operate. Ventilation for the academy's privies was provided by a constantly open window (both in summer and winter), which practically resulted in high temperatures during the summer, leading to discomfort. In winter, the temperature inside matched that outside, resulting in numerous signs of freezing and damage visible across the entire surface of the walls; this season alleviated the unpleasantness of odors and insects. These privies likely functioned for several decades before the military deemed them impractical and unsanitary. It can be assumed that this was a kind of architectural and sanitary experiment, the realization of which necessitated the demolition of the entire external wall of the building, the vaults, the removal of the basement, and the rebuilding of a new structure with niches. A surprising discovery was the openings in the boards, which not only had anatomical cutouts but also varied shapes (ranging from circular to oval to heart-shaped). That they have survived to this day is due to an extraordinary coincidence (Fig. 18).

Fig. 18. Floor of a residential/craft building from the 16th century after cleaning and exhibition, photo by K. Janus, 2023

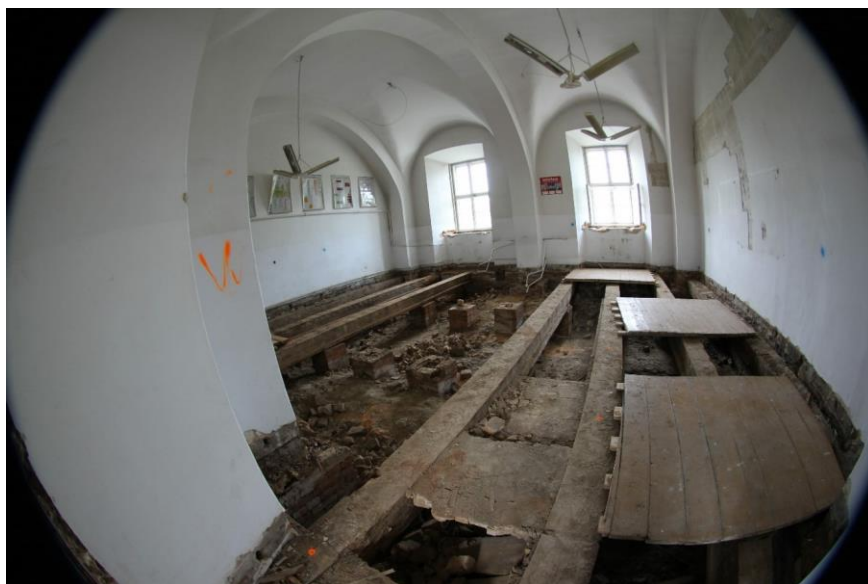
Fig. 20. Kanty's Room before the start of conservation work, showing the ventilated floor, photo by K. Janus, 2021

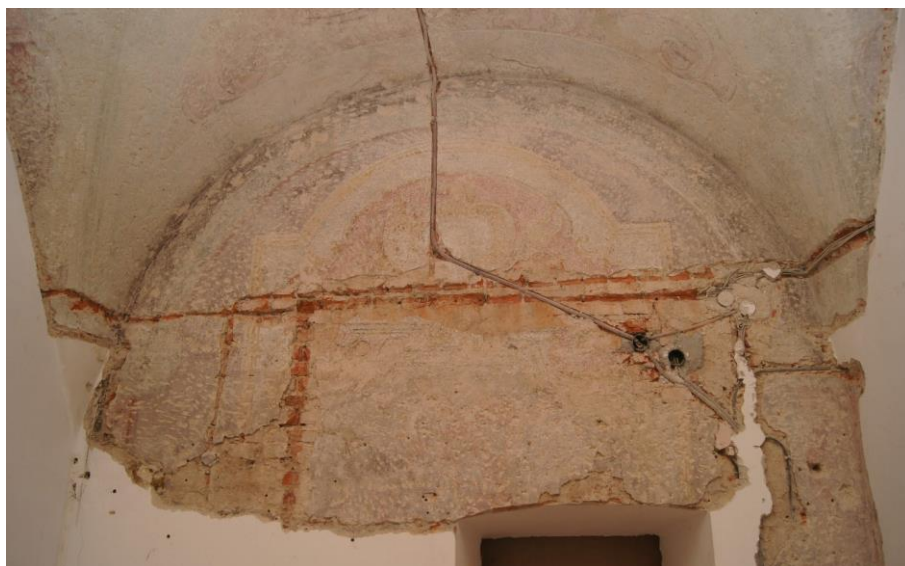
Fig. 22. Former chapel during the uncovering of polychromes, photo by K. Janus, 2021

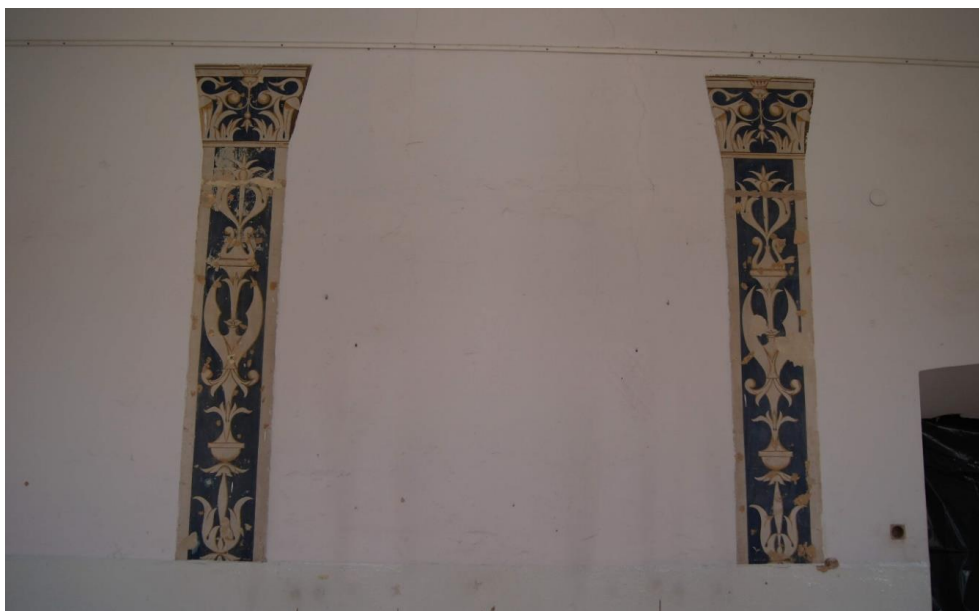
Fig. 26. One of the walls of the former library with fragments of interwar polychromy, photo by K. Janus, 2021

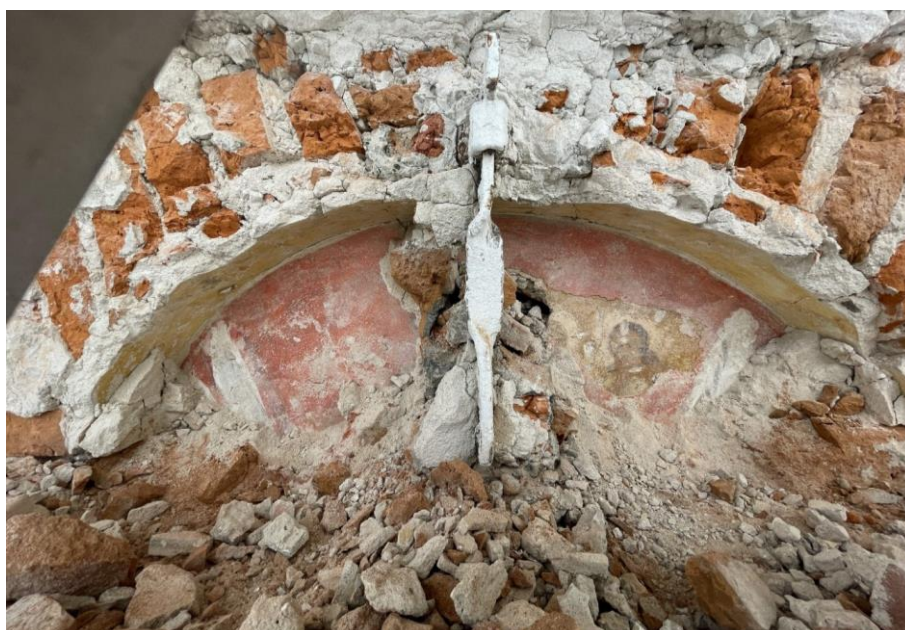
Fig. 29. Niche above the entrance on the western side shortly after discovery, photo by K. Janus, 2023

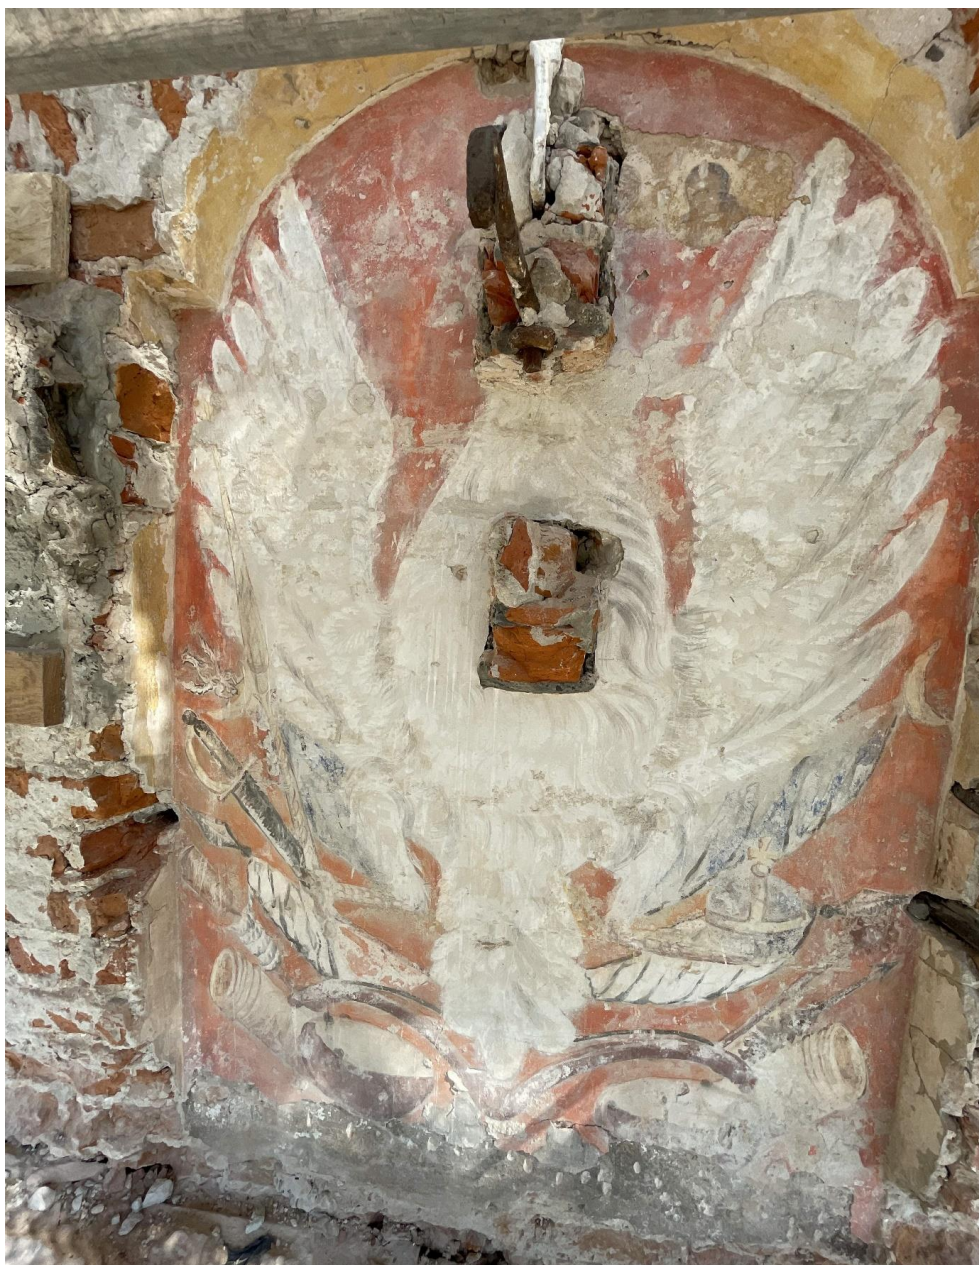
Fig. 30. Niche above the entrance on the western side with the uncovered Congress Eagle,  
photo by K. Janus, 2023

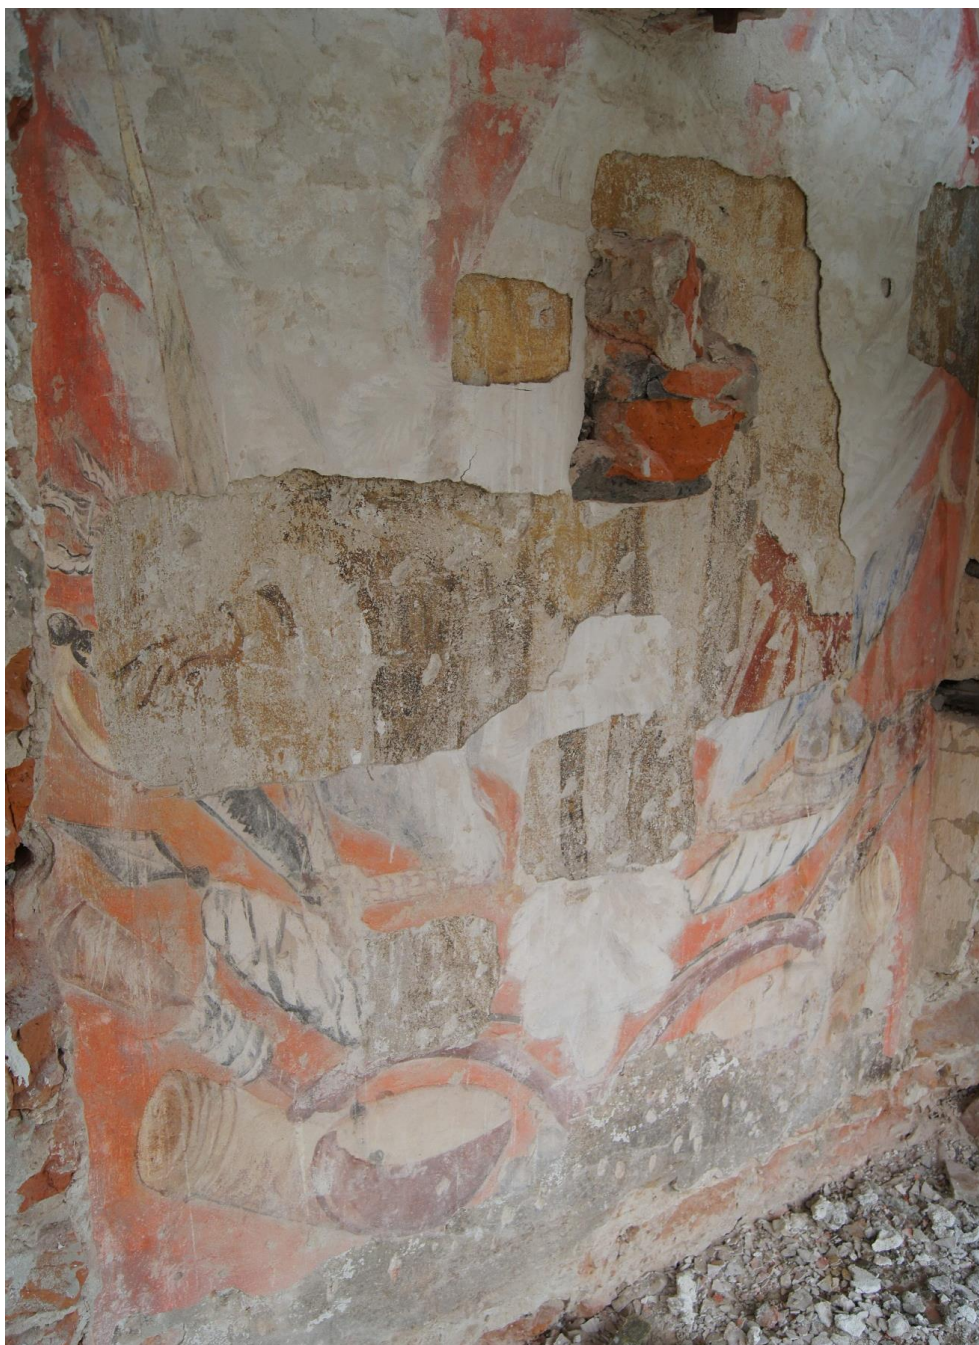
Fig. 31. Niche above the entrance on the western side after conservation excavations, photo by K. Janus, 2023
