## RENOVATION OF LARGE-PANEL BUILDINGS IN CONTEXT OF URBAN RENEWAL

### Abstract

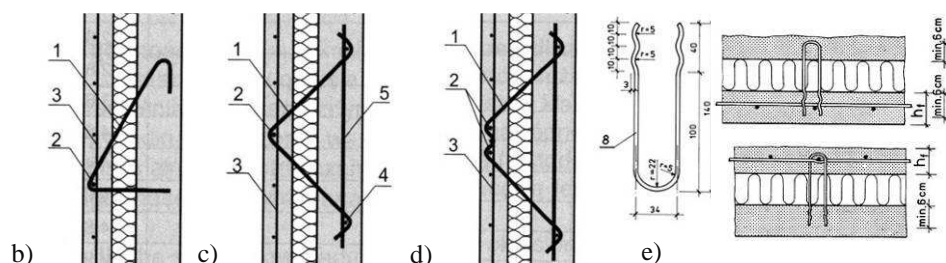
Fig. 4. Connection between load-bearing and texture layer in ZWS and ZWO type walls: a) model for joining with flexible connectors (hangers + pins), b) hanger with tensiled inclined arm, c) "one-humped" hanger, d) "two-humped" hanger, e) pins; 1 - hanger, 2 - element anchoring the hanger in the texture layer, 3 - reinforcing mesh for texture layer, 4), 5) - bar anchoring the hanger in the load-bearing layer

Defects in connecting (hooks, pins) the vapor-control layer with the load-bearing layer of prefabricated ZWS and ZWO wall panels (Fig. 7, Fig. 8) and cracks in the vapor-control layer (Fig. 9) are not connected with damage (cracking) in the joints and do not pose a safety threat to the load-bearing construction of the building. However, they do pose a potential safety threat to its use as a result of the possibility of destruction occurring in the vapor-control layer and, in extreme cases, its separation (Fig. 12). The safety threat to the
