NON-DESTRUCTIVE TESTING OF WOODEN ELEMENTS IN HISTORIC BUILDINGS - AN EXAMPLE OF TESTING A 19TH CENTURY ROOF TRUSS STRUCTURE

Joanna DROBIEC, Beata NOWOGOŃSKA¹

University of Zielona Góra, Institute of Civil Engineering, Zielona Góra, Poland

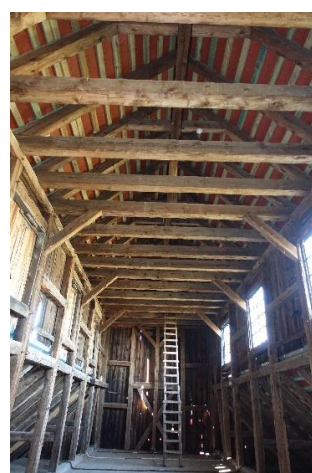
Fig. 4. A detail of the attic (photo by J. Drobiec)

The church interior originally had an open space with organ galleries at side and east rear walls (Fig. 3). Nowadays, there are two rooms: a vestry and a utility room in the north-western and south-western corners. At the west wall there is a new post-conciliar altar in the place of the original pulpit altar characteristic for Protestant religion. All interior walls are covered with wooden panelling. The ceilings over organ galleries and the main part of the church are wood slab ceilings, stairs to these organ galleries and to the attic are wooden stringer stairs. The Polish cross gable roof forms the timber roof structure (Fig. 4). The roof over the central nave has a collar beam structure with a queen post truss and ridge purlin.

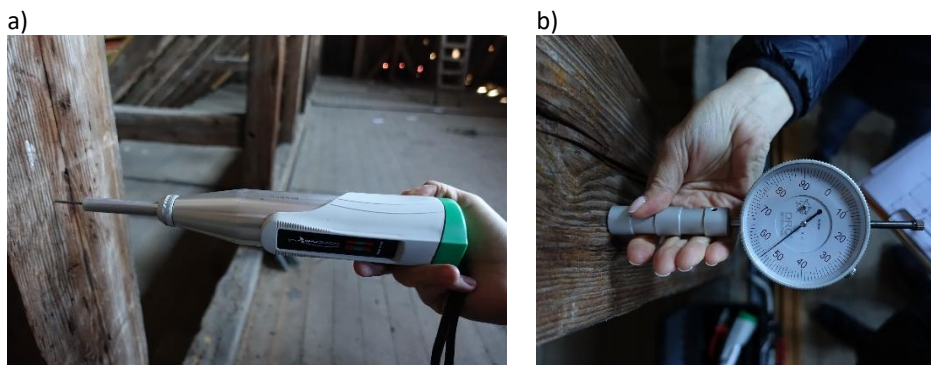
Fig. 6. Sclerometric tests:
a) hammering the needle into the wood element, b) measuring a sticking part of the needle

The hammer test consists in hammering the needle with a diameter of 2.5 mm and a length of 50 mm into the analysed component. The needle is made of stainless-steel grade with 60 HRC with a 35°-angled cone. The impact energy is 2.207 Nm. The needle penetration was measured after 5-time hammering using a dial indicator. The tests were performed on the selected components of the roof truss system (Fig. 6, 7). The tested components had no signs of biological corrosion or had some visible signs of damage. The test results are presented in Table 1.

The qualitative assessment of wood was performed on the basis of the results from sclerometric tests. The needle penetration was deeper in case of corroded elements. An average depth of the needle penetration into the undamaged elements was 23.07 mm at the standard deviation of 1.48 mm (the coefficient of variation was 6.4%), whereas an average depth of the needle penetration into the damaged elements was 31.03 mm.

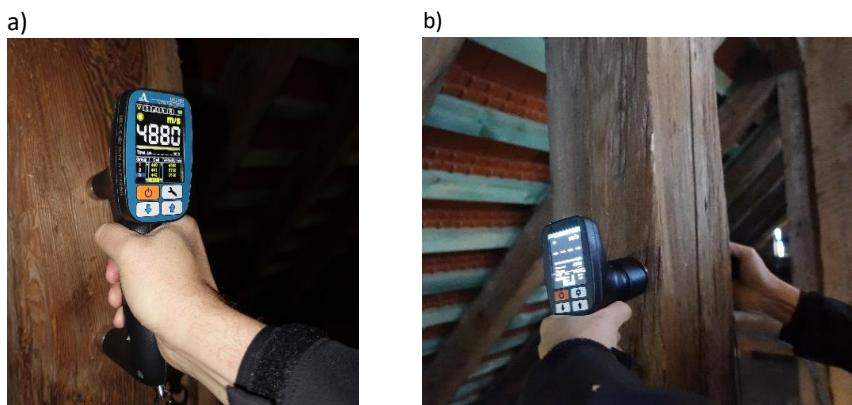
Fig. 7. Ultrasonic tests conducted with: a) UK 1401 SURFER instrument, b) UK 1410 PULSAR instrument

The qualitative analysis of the wood was conducted on the basis of the performed ultrasonic tests. An average ultrasonic velocity for the undamaged elements tested with the instrument UK1401 Surfer (a transverse ultrasonic wave) was 5330 m/s at the standard deviation equal to 184 m/s (the coefficient of variation 3.5%). An average ultrasonic velocity for the components with biological corrosion was 4266 m/s at the standard deviation equal to 865 m/s (the coefficient of variation 20%). The instrument UK1401 Surfer was also used to test defects (knots). Nine defect sites were tested with the transducer

An average ultrasonic velocity for the undamaged components tested with the instrument UK1410 Pulsar (the longitudinal ultrasonic wave) was 1994 m/s at the standard deviation equal to 150.1 m/s (the coefficient of variation 7.5%). This velocity for the damaged elements was lower by 32% and equal to 1370 m/s.
