ASSESSMENT OF THE TECHNICAL CONDITION OF THE KOSSAK MANOR GRANARY BUILDING IN GÓRKI WIELKIE

Janusz JURASZEK¹, Roman SIRY, Hubert WALUSIAK

Univeristy of Bielsko-Biała, Faculty of Materials Engineering, Construction and Environment,
Department of Construction, Poland

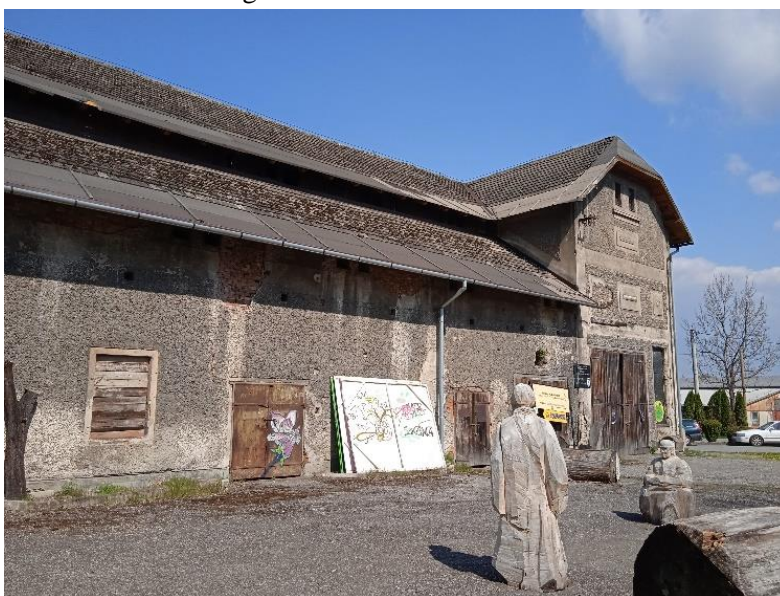
Photo 1. South-east elevation of the Kossak Manor Granary - current state

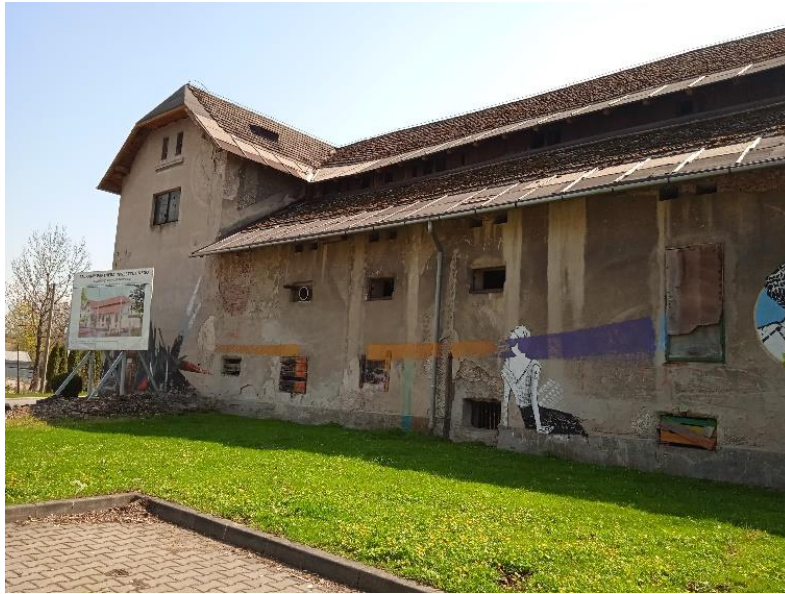
Photo 2. The north-western elevation of the Manor Granary – existing condition

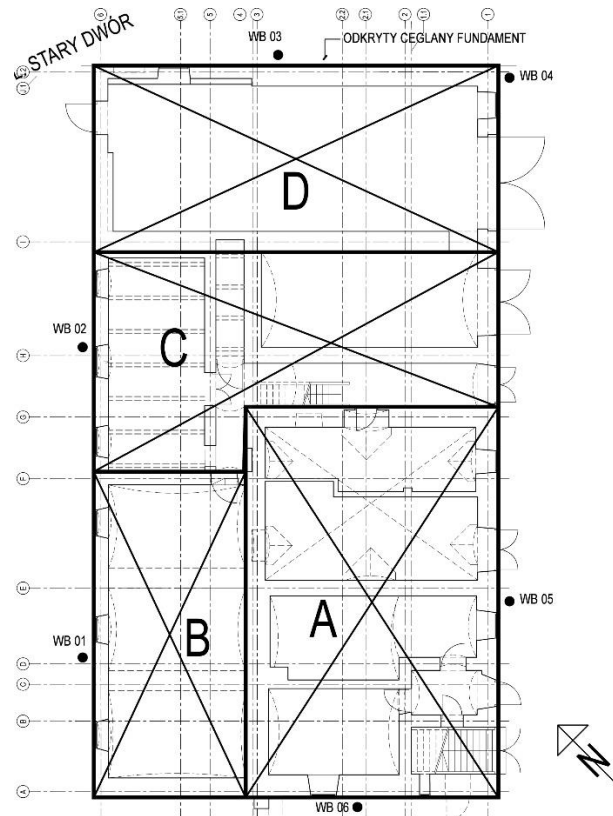
The building has been divided into at least four segments (designated from A to D), taking into account the diversity of materials used in its intended form. This indicates a gradual expansion of the facility. The individual segments are not structurally interconnected, which affects the statics, rigidity, and overall strength of the building structure (Fig. 6). A double-hanger truss was installed above segments A-C, while a single-hanger truss was installed above segment D.

Fig. 6. Ground floor plan with division into segments of the Kossak Manor Granary building

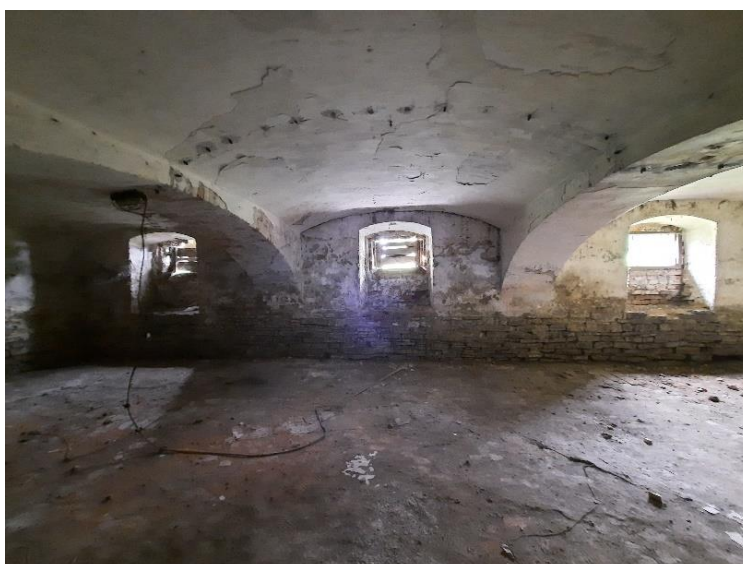
Segment B: It has a part of the basement with barrel vaults supported by brick transverse arches (photo 5).

Photo 5. Basement with barrel vaults supported by transverse arches
