## REVITALIZATION OF A RESIDENTIAL-COMMERCIAL TENEMENT HOUSE IN MYŚLIBÓRZ AT RATUSZOWA STREET 11

### Abstract

The article discusses the current issues related to the revitalization of a building fully protected by conservation laws. The work covers a wide range of activities involved in the construction process aimed at fully restoring the functional qualities of historical architecture, while also ensuring the proper exhibition of preserved cultural heritage elements. The analyses, study materials, and design works carried out enabled the implementation of construction works for this unique building. To illustrate the research problem, the method of a selected case study was used, and design activities (Research Through Design) were incorporated into the research process. The subject of the study is a specific building – a monument, which also serves as a representation and an example of a neglected spatial structure within a historic inner-city complex. Based on the analysed case, general conclusions were formulated that are helpful in preparing diagnostics and design works related to the revitalization of historical buildings in poor technical condition.

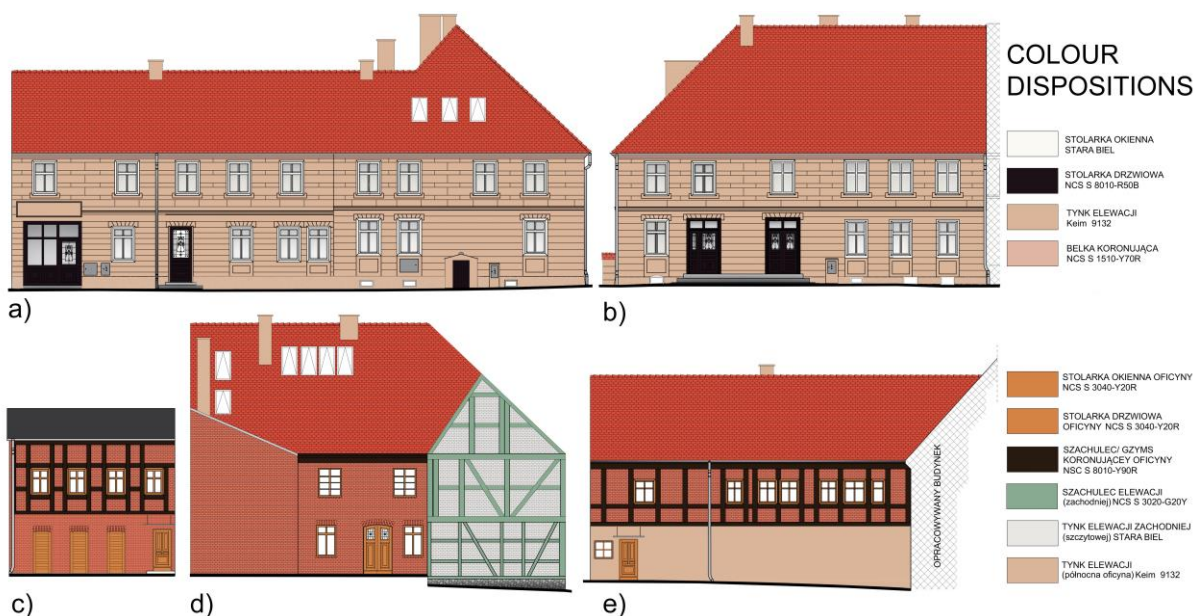
Based on the results obtained from stratigraphic studies, the color scheme for the external façades of the tenement house (Fig. 5a-e) and the interior of the main entrance hall, including the existing stairs, was developed. The color selection referenced the historical color scheme.

<p>Plaster (eastern front elevation)</p> <ol style="list-style-type: none"> <li>1. Gray trowel finish</li> <li>2. Thin paint layer light beige ochre</li> </ol> <p><b>Colour used: Keim 9132 ochre</b></p>

Fig. 5. Facade – Color Scheme Design: a) the southern side facing Mariacka Street (southern annex and main building), b) eastern side facing Ratuszowa Street (main building), c) southern side of the northern annex, d) western side of the main building and the annex gables, e) northern side of the southern annex. Source: authors' own work based on project documentation [34]

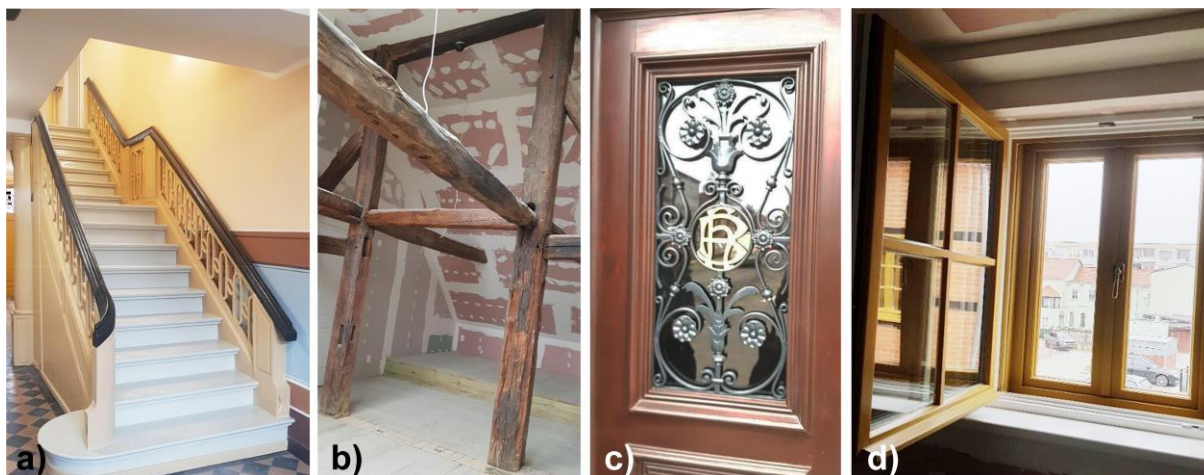
5	Relocation and restoration of one of the three preserved tile stoves – the stove from the living room on the first floor was moved to the hall on the ground floor, while the remaining two stoves were dismantled and handed over to the Investor (the original conservation work program had planned to preserve all three stoves) (Fig. 6h).
6	Abandonment of the complete fire protection enclosure for the public staircase on the ground floor (main hall) and the structural elements of the roof truss in the attic of the main building, for their exposure (Fig. 7a-b)
7	Removal of the secondary extension with door (Fig. 4b) at the basement exit from Mariacka Street.

In addition, based on the conclusions of complementary research, it was decided to commemorate the former owner of the tenement and to preserve one of the original pieces of technical infrastructure. It was established that the initials "HB" on the preserved metal grille of the external door on the ul. Rynkowa side belonged to the building's owner, Herman Böhme, who operated his shop there from the early 20th century (Fig. 7c). The grilles with the former owner's initials were also placed on two other newly created doors, modeled after the originals, installed on the facades facing the streets. In turn, an information board with the history of the monument has been installed on the gable wall of the south outbuilding (Fig. 6c). During the construction work, archaeological research uncovered a historic dug well with a brick casing. The decision was made to preserve the well as a historical witness, and it was conserved and protected with a concrete slab at ground level (Fig. 6e).

Fig. 7. The tenement house after the revitalization: a) Internal staircase in the main hall, b) Attic above the main body with exposed roof truss structure, c) Metalwork on the entrance doors with the initials of the former building owner, d) Original box window - first floor of the southern annex. Source: preparation and photographs by the authors
