THE LOAD-BEARING CAPACITY OF TIMBER-GLASS COMPOSITE I-BEAMS MADE WITH POLYURETHANE ADHESIVES

Konrad RODACKI¹

Cracow University of Technology, Kraków, Poland

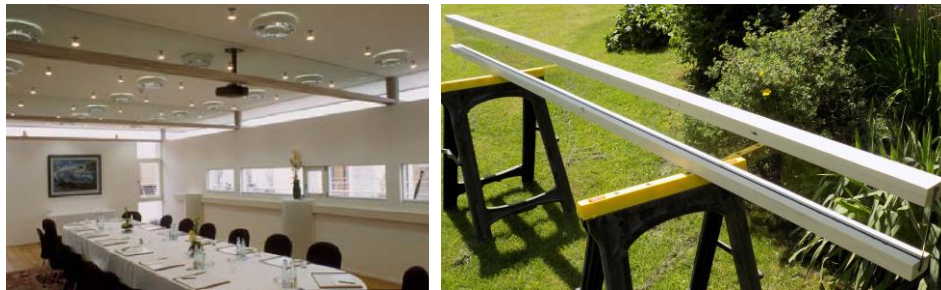
Fig. 1. Flat roof structure in the Palafitte Hotel, Switzerland [1] (left), timber-glass beam prepared for own test (right)

materials. Composite timber-glass I-beams are one such type of element (Fig. 1). These composite beams enable us to maximise the strongest properties of both materials: for glass, it is its high stiffness and compressive strength; for timber, its high ductility, its ability to plasticise and the ease with which it can be worked. The connection of these two materials is achieved by the adhesive layer. The radically different nature of the load nature and the required bond rigidity are the main problems that arise during the selection of the adhesive. The best adhesives for static loads are those with high rigidity to ensure full fusion, and for dynamic loads (multiple-variable or seismic), adhesives with low rigidity that protect the glass from damage are better.

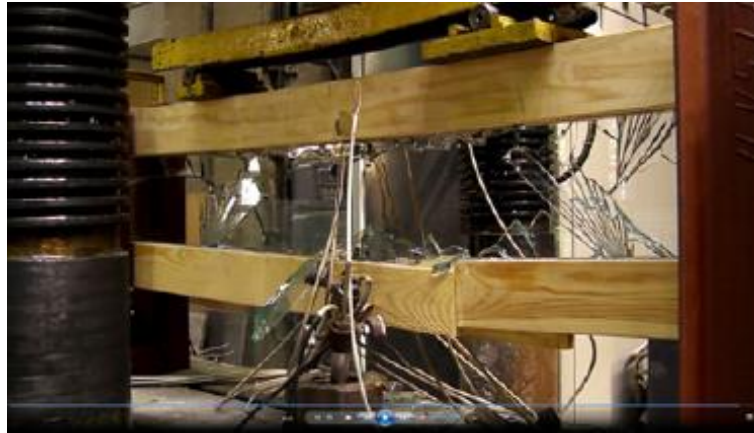
Fig. 4. Failure of composite timber-glass I-beam through the tension fail of flange [10]
The manner of finishing the glass edges has a significant impact on the bending capacity of composite timber-glass I-beams - this is presented in studies [18, 19].

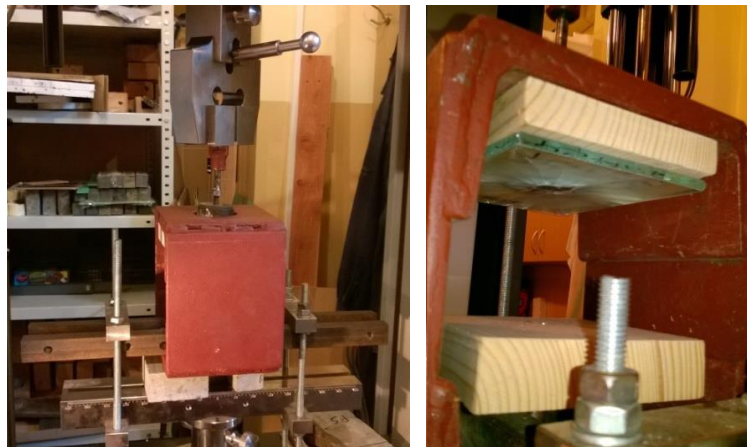
Fig. 5. Timber element (left) and glass element with timber spacer (right) mounted in the investigation tool during the pull-off tests

The elements were mounted in the special steel element (Fig. 5), and to avoid stress concentrations, the glass elements were attached using a timber spacer. The

head bolt was screwed into an aluminum cylinder to provide a hinge joint and placed in the upper jaws of the machine. The moisture content of the timber elements just after adhesive failure in the adhesive area was 11.2% on average. The elements were loaded quasi-statically and continuously at a speed of 2mm/min until rupture occurred. The joint capacity of elements in which the adhesion to timber surface was investigated depends on the tension strength of timber transversal to grains (failure occurred in the timber) (Fig. 6), and in some cases, the adhesive layer (failure occurred in the adhesion zone). All connections made with the Sika®PT adhesive broke at a similar level of force regardless of whether the bonding surface was primed or not. For the Sika®PS polymer, it can be concluded that surface priming improved polymer adhesion strength to the bonding surface by approximately 10%. In the case of the Sika®PM polymer, the influence of timber surface priming on the joint capacity was not determinable. The graphs in Fig. 7 show the force-displacement dependence for investigated elements bonded with the Sika®PS polymer. As can be observed, in general, the joints broke rapidly during the pull-off test, and the joint behaviour under loading could be described by a linear function for all of the investigated polymers.

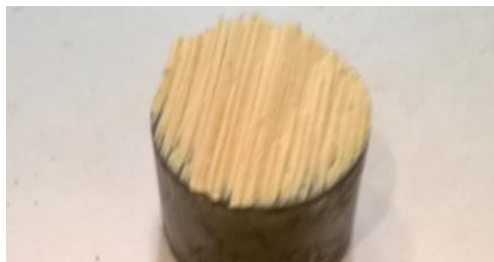
Fig. 6. Failed timber-adhesive joint after pull-off testing of Sika®PS polymer

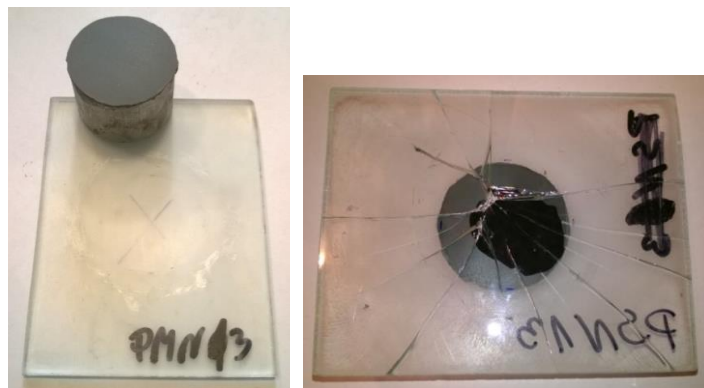
Fig. 8. Failure in glass-adhesive zone (left) and glass failure on bending (right)

On the basis of the pull-off testing of joints, it can be noted that the investigated polyurethane adhesives present very strong adhesion to both glass and timber. It should be noted that detached wood grains were present on the adhesive surface for all experimental elements with which the destruction zone was in the adhesive-timber zone. The joint peel capacity is then comparable with, or even greater than, the tensile strength of the timber perpendicular to the grains. Nevertheless, the Sika®PT polymer seems a bit too stiff for combining with glass because of its vulnerability to rupture joint failure. One of the most significant findings of the research is the fact that Sika®PS adhesive, with the appropriate preparation of glass surface, provides the greatest peel capacity within all investigated adhesives in this paper. It can be assumed that peel stresses in the joint are much more uniformly distributed for the Sika®PS polymer, as indicated by the radial arrangement of the failure cracks in the glass (Fig. 8).

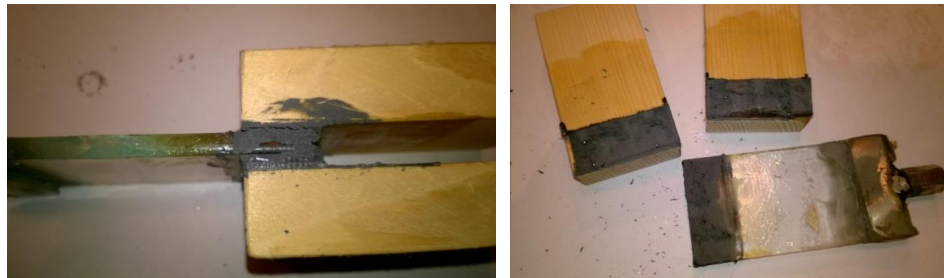
Fig. 10. Failed double lap joint (left), morphology of slide plane in adhesive layer (right)

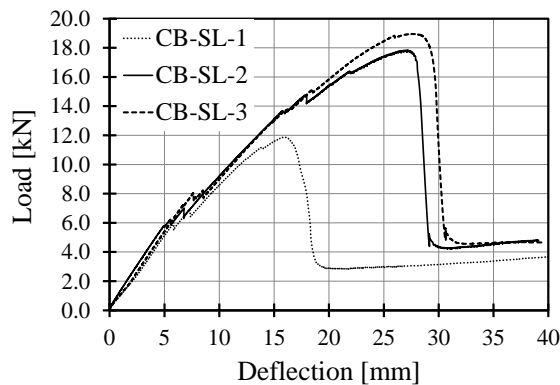
Fig. 15. Dependence of the mid-span deflection on the value of applied loading for all investigated beams

All tested elements responded in an almost perfectly linear-elastic manner until the first crack appeared. After the first crack appearance, the jump on the force-deflection graph can be seen, but after stabilisation and following the increase of load, the elements still respond in a linear-elastic manner until complete failure (Fig. 15). All three tested items failed as a result of the shear strength being exceeded in the adhesive bond layer near to the beam support (in places where the shear stress are the biggest).

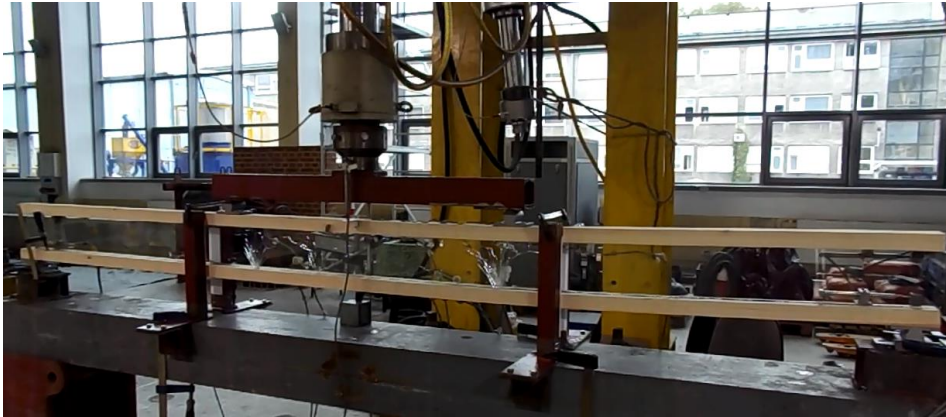
Fig. 16. Photo of failed composite timber-glass I-beam

All investigated elements failed in a ductile manner which was signalled long before the fully loss of capacity. Even after the final destruction, ie. the loss of the ability to sustain a further increase of load, elements did not disintegrate. The

tensioned flange was still able to keep all parts of the cracked web together, even for a 60mm beam deflection (Fig. 16).
