TECHNOLOGICAL CONSIDERATIONS OF PERIODIC REPAIR WORKS OF CONCRETE INDUSTRIAL FLOORS

The paper presents a collection of practical information related to conducting periodic repair work on concrete industrial floors. The article is a case study and addresses specific situations related to the loss of serviceability of concrete industrial floors.

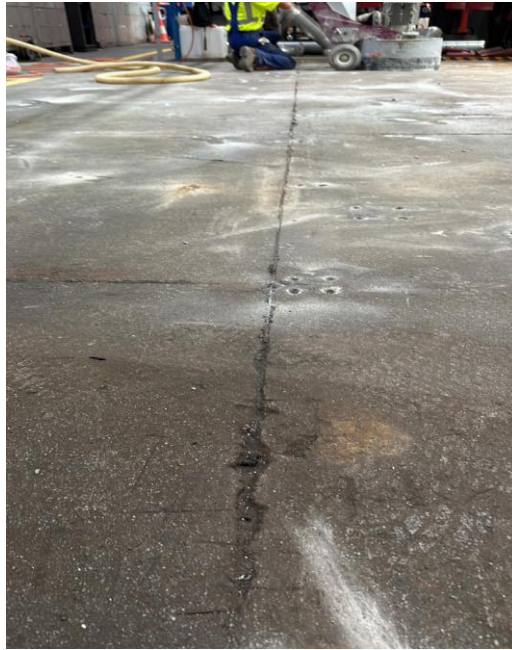
Example 1 is a floor in several years of use, located in a manufacturing plant in a section for welding steel components (Fig.2, Fig. 3).

Fig. 2. Degraded concrete industrial floor (Example 1): visible wear of the top layer, mounting anchors left over from equipment removal, and shrinkage joint damage [38]

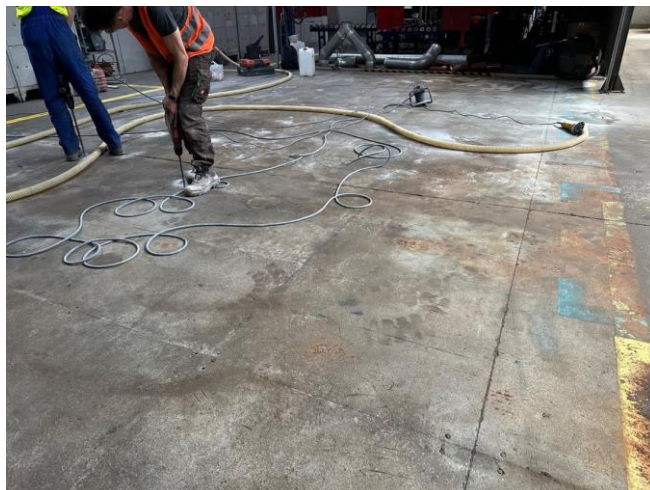
Fig. 3. Degraded concrete industrial floor (Example 1) during repair: damage inventory, removal of mounting anchors [38]

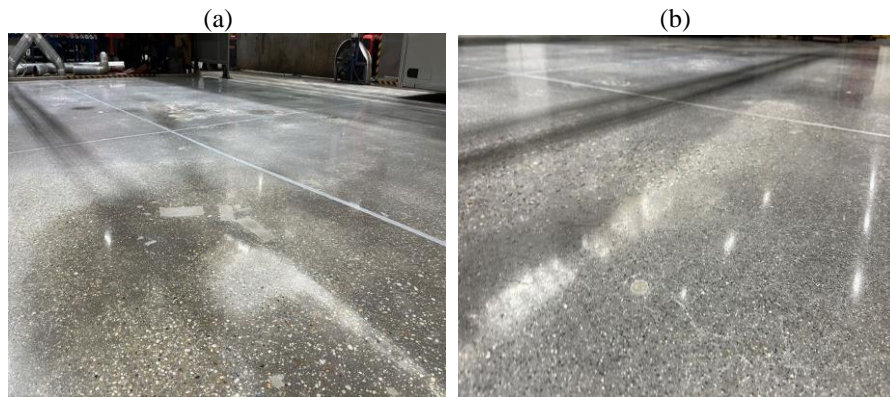
Fig. 8. Concrete industrial floor (Example 1) after repair: a) visible areas of repair of cavities b) visible areas of repair after anchors [38]

After drying, polishing was started with a white polishing pad using a high-speed polisher (Fig.8). To complete the work, the edges of the expansion joints were restored, and the expansion joints were filled with polyurethane compounds (Fig.9).

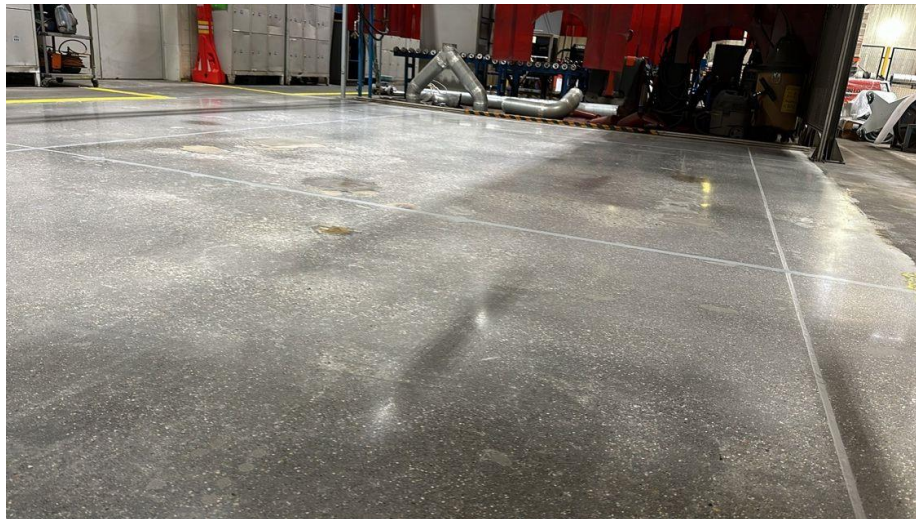
Fig. 9. Concrete industrial floor (Example 1) after repair: general view and visible reconstructed and completed shrinkage expansion joints [38]

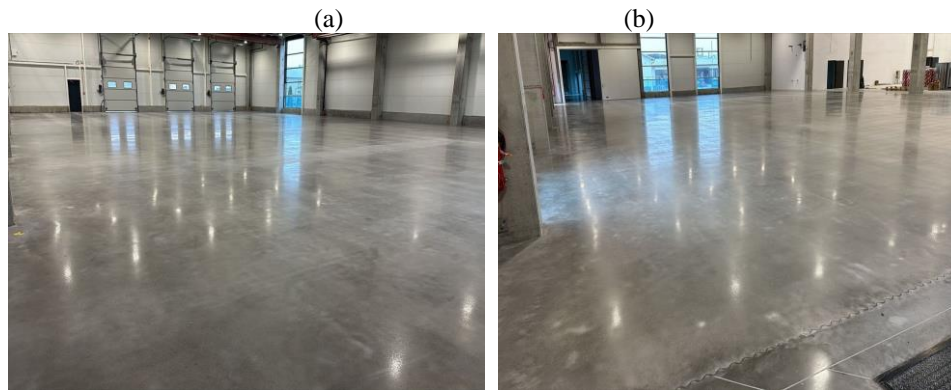
Fig. 13. Concrete industrial floor (Example 3) after regeneration by polishing and impregnation process: a) general view, b) view of pavement treatment in the area of structural expansion joints [38]

Due to the low level of wear and tear from use, the grinding process omitted the use of metal pads, and the entire restoration process began with grinding with plastic diamond discs with a gradation of 50 for honing. The floor was then reinforced with a silicate composite-based impregnant, and final grinding was performed with discs with gradations of 100 and 200, which increased its resistance to abrasion, intensive washing (Fig.13).

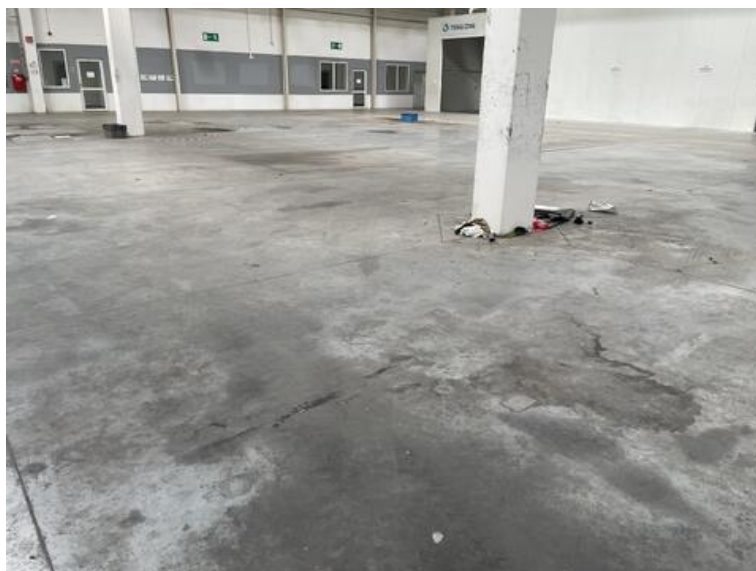
Fig. 14. Concrete industrial floor (Example 4) before renovation: damaged upper floor surface due to improper use of cleaning agents [38]

The ~6,800m² facility was in dry production, but leachate from machinery and equipment in the form of chemicals, oils and grease, permanently penetrated the floor structure (Fig.14). The floor required thorough washing and cleaning with specialized chemicals. Locally degraded parts required rough sanding, which took place on about 5% of the hall's surface. More than 6,000 anchors were removed from the floor, along with the repair of the areas after their removal. During the renovation work, it was found that all working expansion joints were subject to edge displacement and there was so-called slab keying associated with deformation and settlement of the substructure.

In the course of the work, a decision was made to repair the substructure and thus support the edges of the expansion joints by pressure injection, which was eventually carried out in the amount of ~1200 mb of expansion joints.

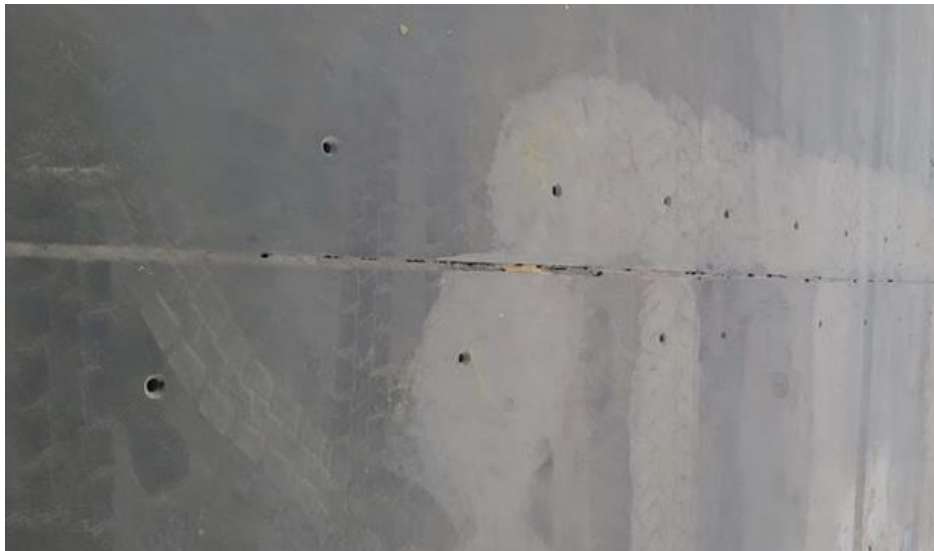
Fig.15. Concrete industrial floor (Example 4) during repair:
diagram of drilled holes for injection feeding [38]

The repair by injection consisted of drilling ~14 mm diameter holes in the floor along the working expansion joints (Fig.15). The holes were drilled to the full thickness of the floor alternately on both sides of the expansion joints. The distance of the holes from the edge of the slab is ~30 cm, and the spacing between adjacent holes does not exceed 60 cm. At the corners of the slabs, it was recommended that the spacing be halved to maximize stabilization of the most sensitive areas.
